## Chris CM Gerards

2/20/2023

Hi Kristen,  
I inspected the trees shown on the above photograph and here are my findings:

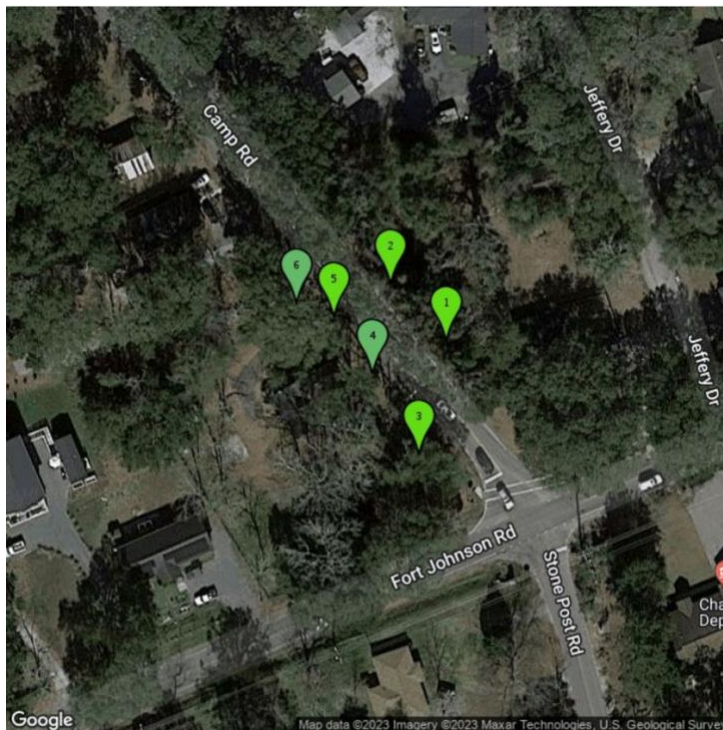
Tree number one is a 36-in live oak. Tree with a small basal wound. Intense vine infestation. There is a cavity about 16 ft up the trunk that looks like it's occupied by an animal for nesting,

indicating a hollow. Tree has an old pruning wound that is heavily calloused about 10 ft up the trunk. Tree is an aged specimen. Tree is in fair condition.

Tree number two is a 44-inch live oak. She has a 12x12-in basil wound. Wound doesn't show extensive decay. Tree is an aged specimen. Tree is infested by vines. Tree shows decay and a cavity in the canopy of the right limb that could represent significant weakness. This needs to be inspected via aerial inspection. Tree is in fair condition.

Tree number three is a 30-in live oak in good condition. Tree has significant dead wood in the canopy. Tree has a superficial trunk wound. Tree has some vine infestation. Tree shows growth pattern typical of hurricane recuperation approximately 15 to 20 years ago.

Tree number four is a 32-inch Laurel oak. (In the Charleston arborist report it is noted as a 23-inch tree which might be a typo.) Tree has severe asymmetrical crown due to power line pruning. Tree has a significant decay pocket about 8 ft up the trunk. Tree has major broken stub about 15 ft up that shows a hollow. Remaining part of the tree as a greater than 15° angle from the trunk with a full crown and represents a hazard to the house. This tree is in poor condition and should be removed immediately.

Tree number five is a 31-in live oak with asymmetrical crown. Shows a large pruning cut about 15 ft up the trunk with signs of decay fungi next to it. There is a cavity that shows a hollow in the trunk that is leaning over the roadway. Tree also shows typical recuperation growth from hurricane damage. Tree is in poor condition. Because of the trees severe V-shape and decay at the v and the heavy lean of the leaders, recommend weight reduction, pruning, or removal of this tree.

Tree number six is a 44-inch Laurel oak. Tree shows a significant recess in the trunk in the first 6 ft. This could signify decay or non-viable cambium. Tree has a small cavity on the same side. It looks to be a nesting cavity signifying a significant hollow. Tree is overly mature for its species. Tree shows included bark on the first leader and a stress crack. Tree shows declining canopy. Tree shows another cavity and hollow right past the second fork. Because of its age and its location, tree would be very susceptible to any kind of trauma to the roots. Tree has massive wind load potential. Tree is in poor condition and recommend removal of this tree.

Trees 4,5, and 6 of the trees are not only incompatible to new road construction but are in such bad shape that trees 4 and 6 should be removed immediately and tree # 5 is borderline. Tree #3 (the 30-in live oak) is in good shape and can be preserved. The two live oaks on the left side of the road (#1 and #2) are not in great shape but can be restored to decent specimens. This would depend on canopy inspection of tree number two.

So, the best tree is tree #3, the 31-in live oak. It's in good shape and in the right location where it can possibly be protected from construction damage. Tree #1 and # 2 have issues but could possibly be restored. However, these trees are so close to the proposed construction, I don't see them surviving the process in any of the configurations.
