Michael P. Murphy,
NJ-0146B

November 11, 2022

Re: Camp Road Grand Trees

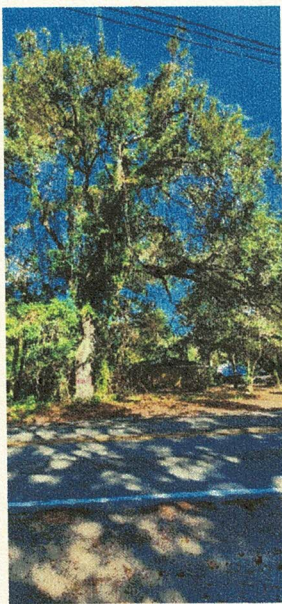
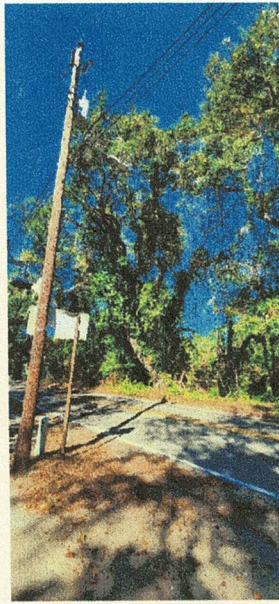
- Both trees have compact canopies relative to their diameter with no dead ends or dieback present in their crowns.
- Leaf color and leaf size is normal as is woundwood formation.
- This compact canopy is partially due to the upper limb reduction that has taken place because of proximized lines crossing the street.

I & II) Compact crowns with no dieback. Proper crown reduction from utility lines.

I have assessed these two trees as "B". If tree pruning is performed by a certified arborist using the Natural Pruning System and the vine, deadwood and larger clumps of Spanish moss is removed from the crown these two trees would be upgraded to an "A". These trees are far from "fair" and well worth another look by the applicants as to their preservation.

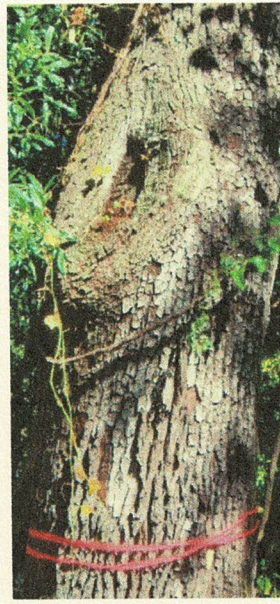
III

III) Healthy woundwood closure from past properly made pruning cut.

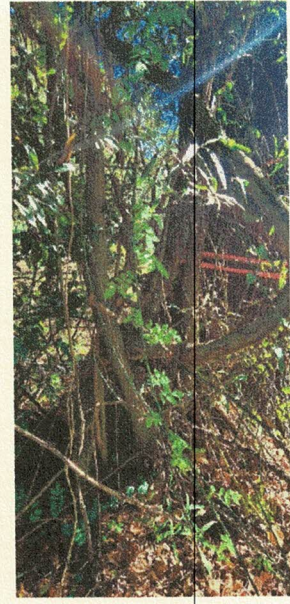
IV

IV) Vines, vines, vines!
