TREE RISK ASSESSMENT

Camp Road (S-28) at Intersection of Fort Johnson Road (S-94)
Charleston, SC 29412

Don Alexander
Parrish and Partners

January 08, 2023

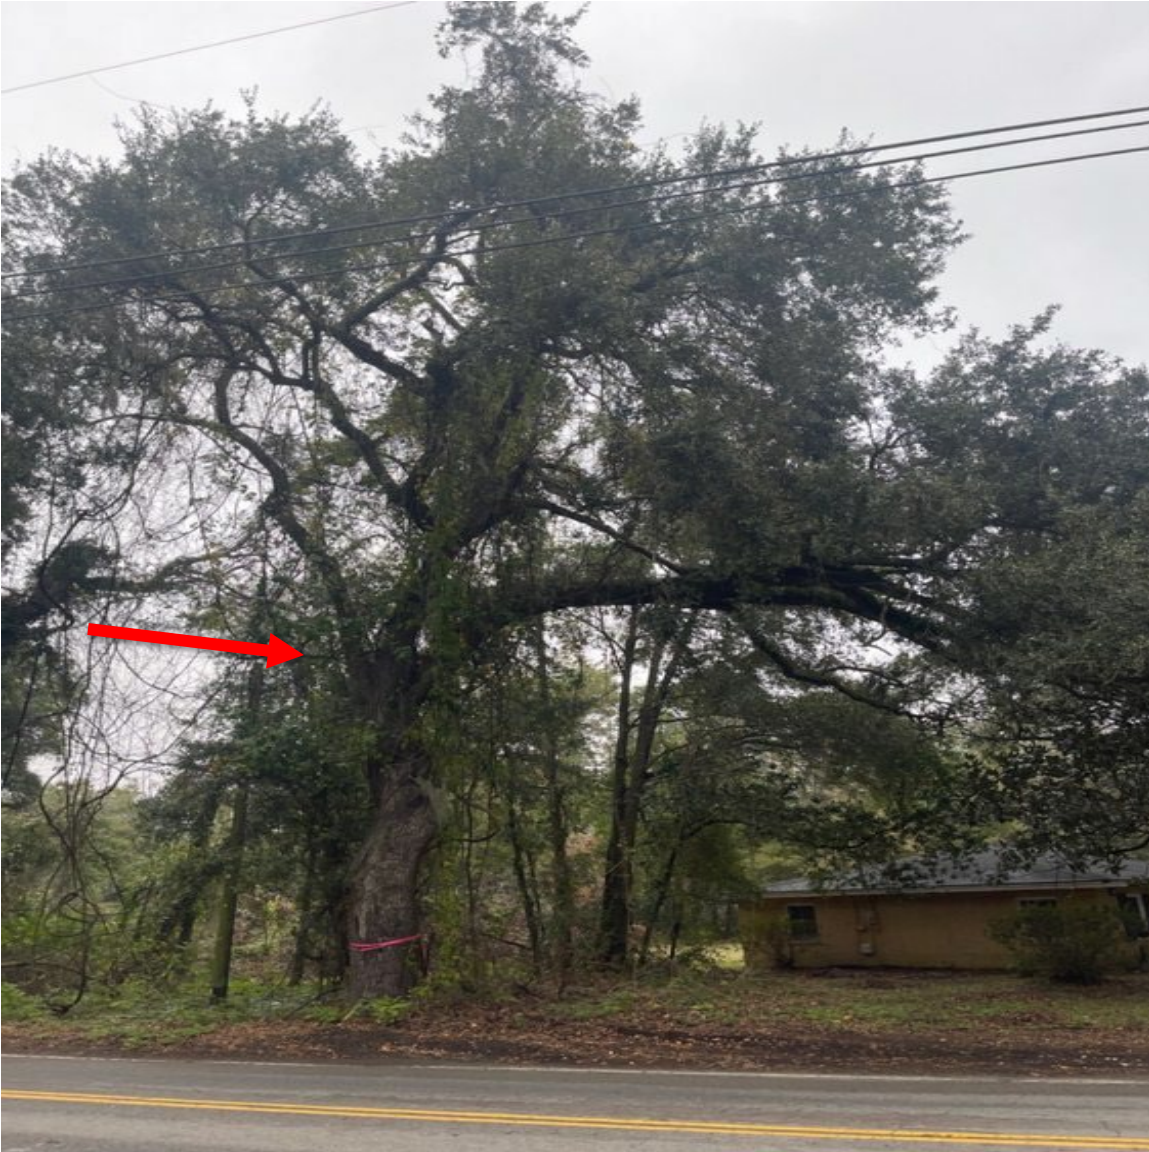
#1 LIVE OAK, *QUERCUS VIRGINIANA*

Upon inspection of the site proposed for road construction, I found a 36" Live oak (Tree #1) to be growing in extremely close proximity (approx. 3') of the North side of Camp Road. I noted a large cavity of decay and extensive damage at the root collar. I performed a sounding test with a rubber mallet and detected hollow in the root collar. Additionally, multiple cavities of decay were found in the main stems making weak points vulnerable to fracturing, pest infestation, and continued rot and decay. The tree's inability to efficiently compartmentalize decay and heal wounds is also an indication of overall declining health and the presence of a wood decay pathogen likely propagating in the woody tissue of this tree. The adjacent tree verifiably contains a white-rot pathogen so I would expect it to be the same here as well. Heavy vine saturation made it difficult to assess the entire tree canopy and I suspect

additional defects are present. Based on the various tire tracks on the ground, I suspect the tree's root system is frequently damaged by vehicles incidentally steering off the roadway. As is, the tree is steadily declining, has a high risk of mechanical failure and poses a hazard to life and property within 1x its height.

Trees #1 and #2: Do not cater plans to retain these trees. Complete removal utilizing ANSI A300 Standards for Tree Care Operations.

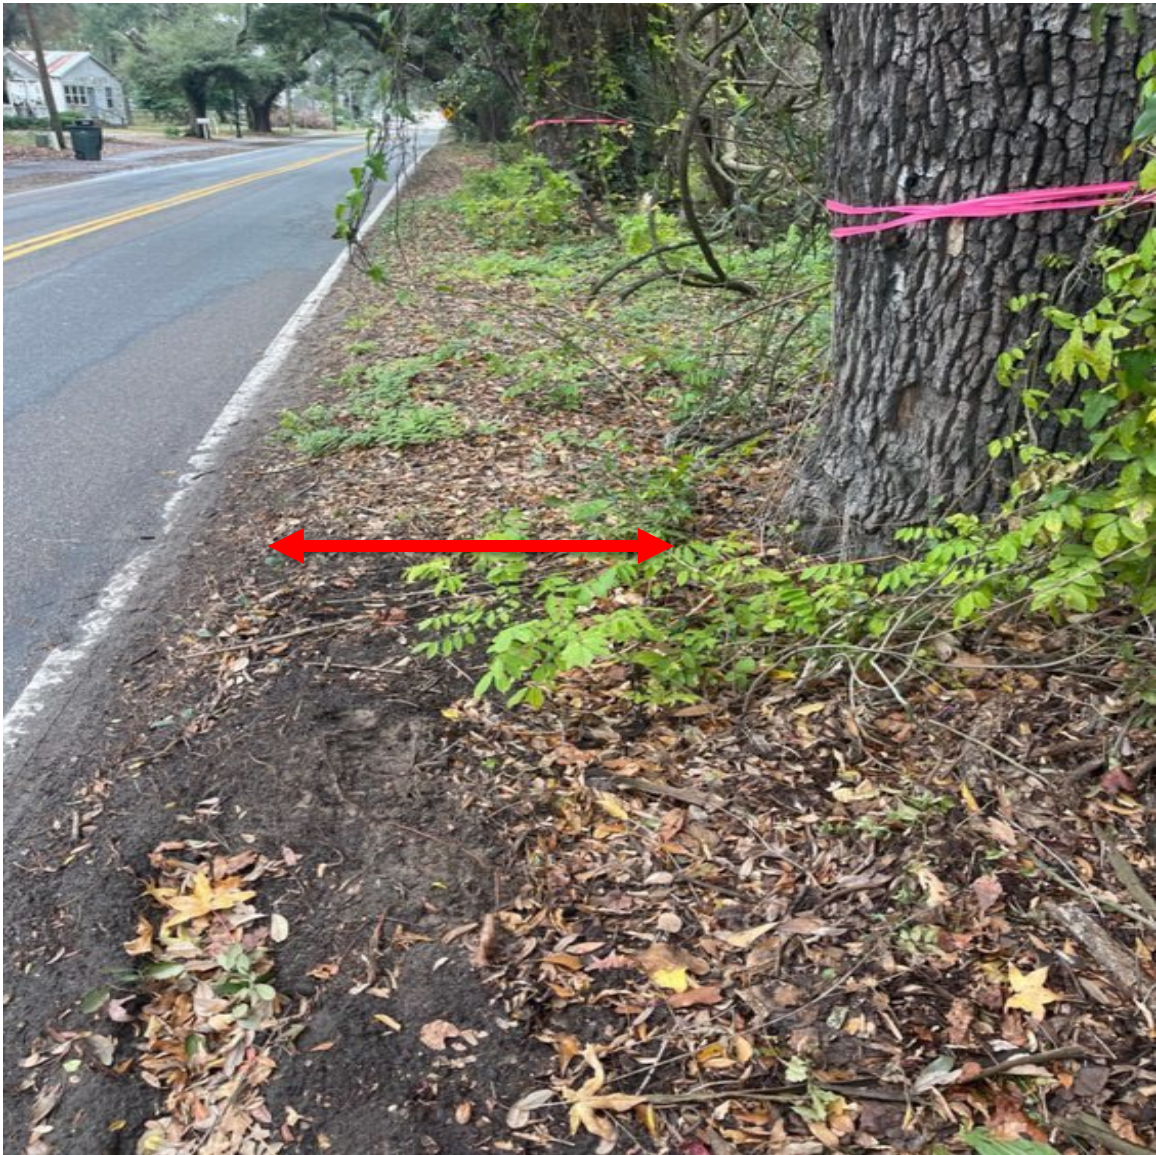
Figure 1: The root collar of this tree is approx. 3 ft from the asphalt edge of the roadway. This would mean that a significant area of the critical root zone and root plate are located beneath the roadway.

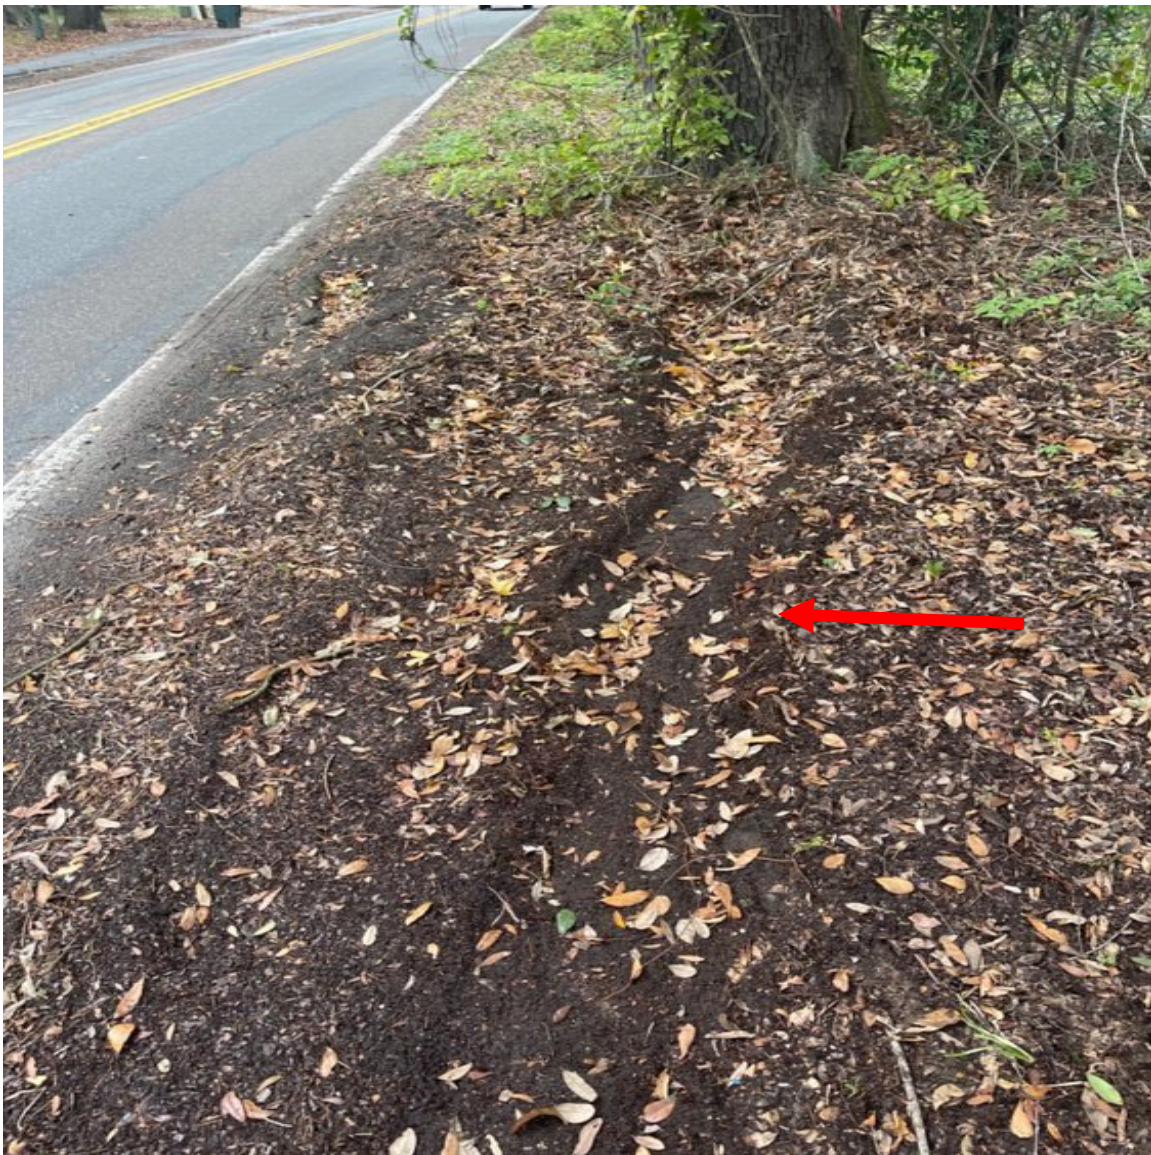
Figure 2: Based on the ground disturbance in this area, I suspect the root system of this tree is frequently impacted by motorist leaving the roadway.

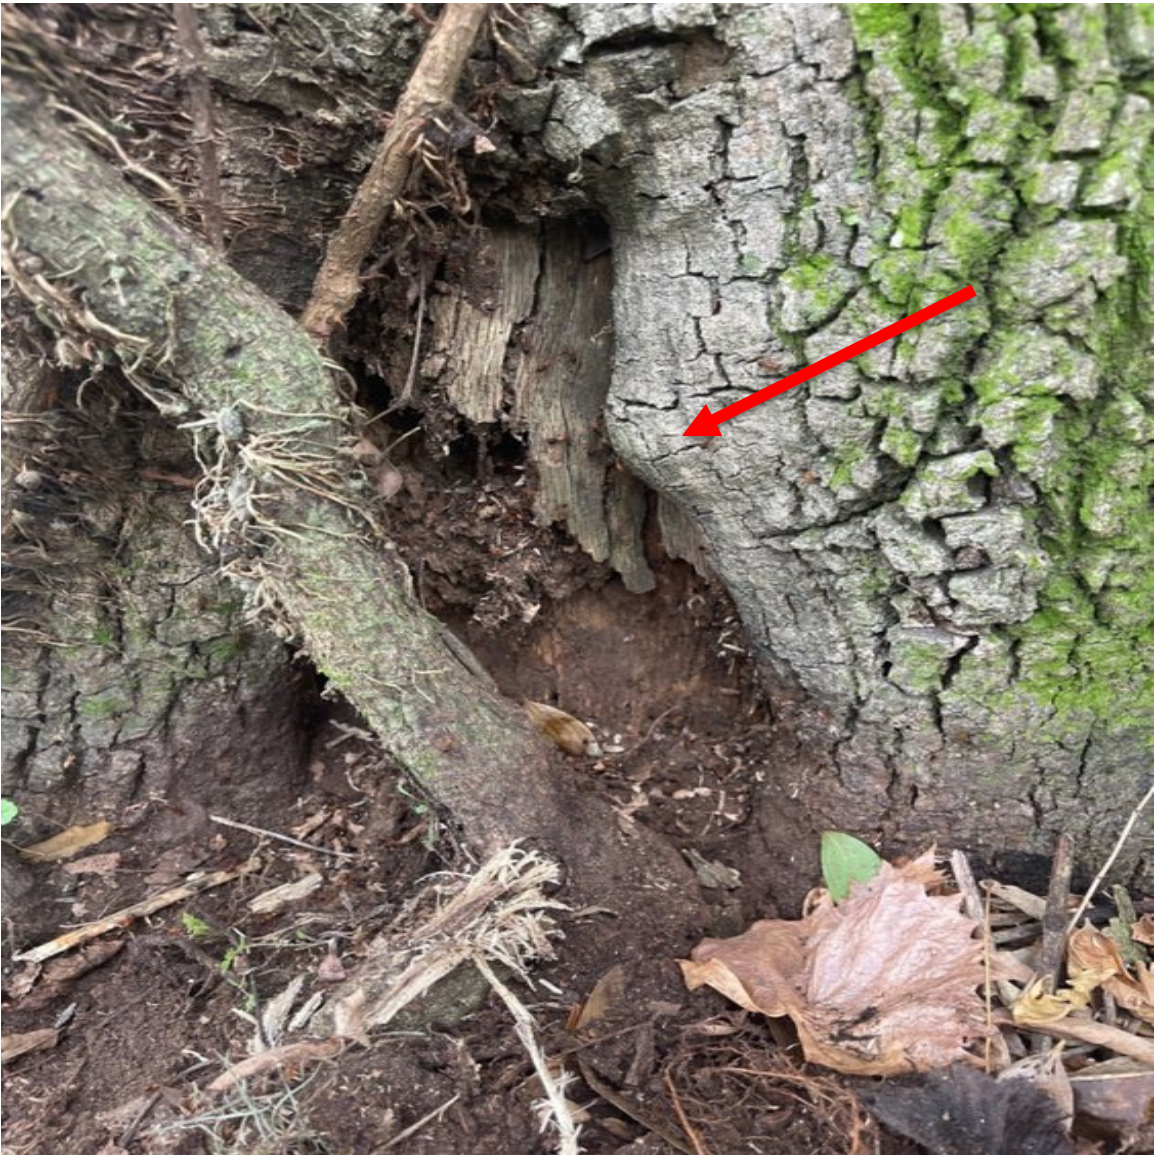
Figure 3: While the tree appears to be compartmentalizing this trauma wound in the root collar, I suspect a wood decay pathogen is already present based on the observed level of wood decay.

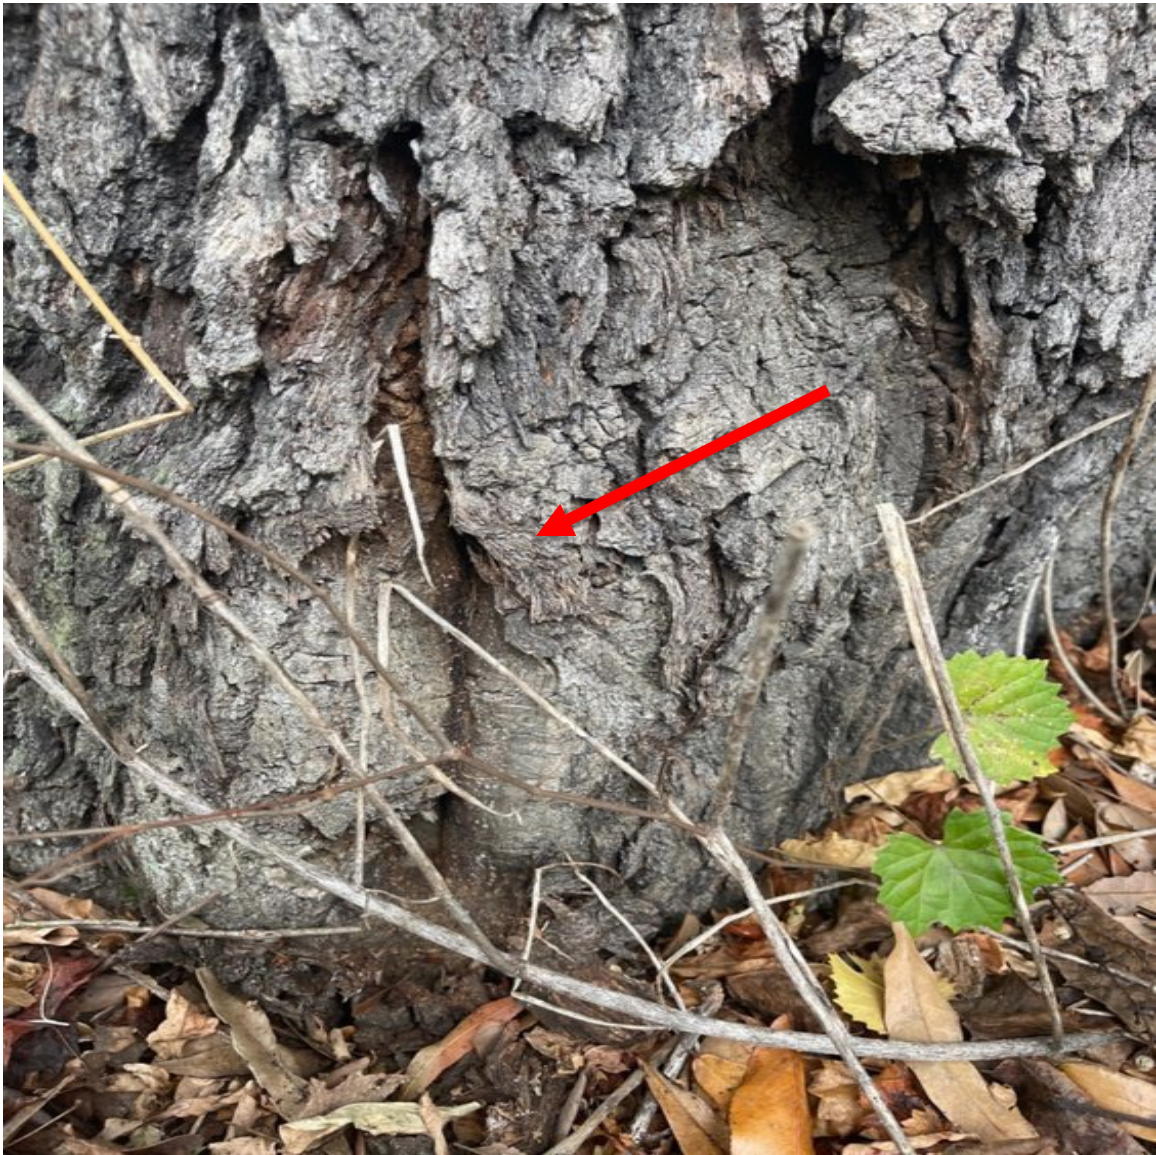
Figure 4: The adjacent wound appears to host internal decay and termite activity. I suspect both wounds are hosting the same wood decay pathogen. Also, note the root collar is buried.

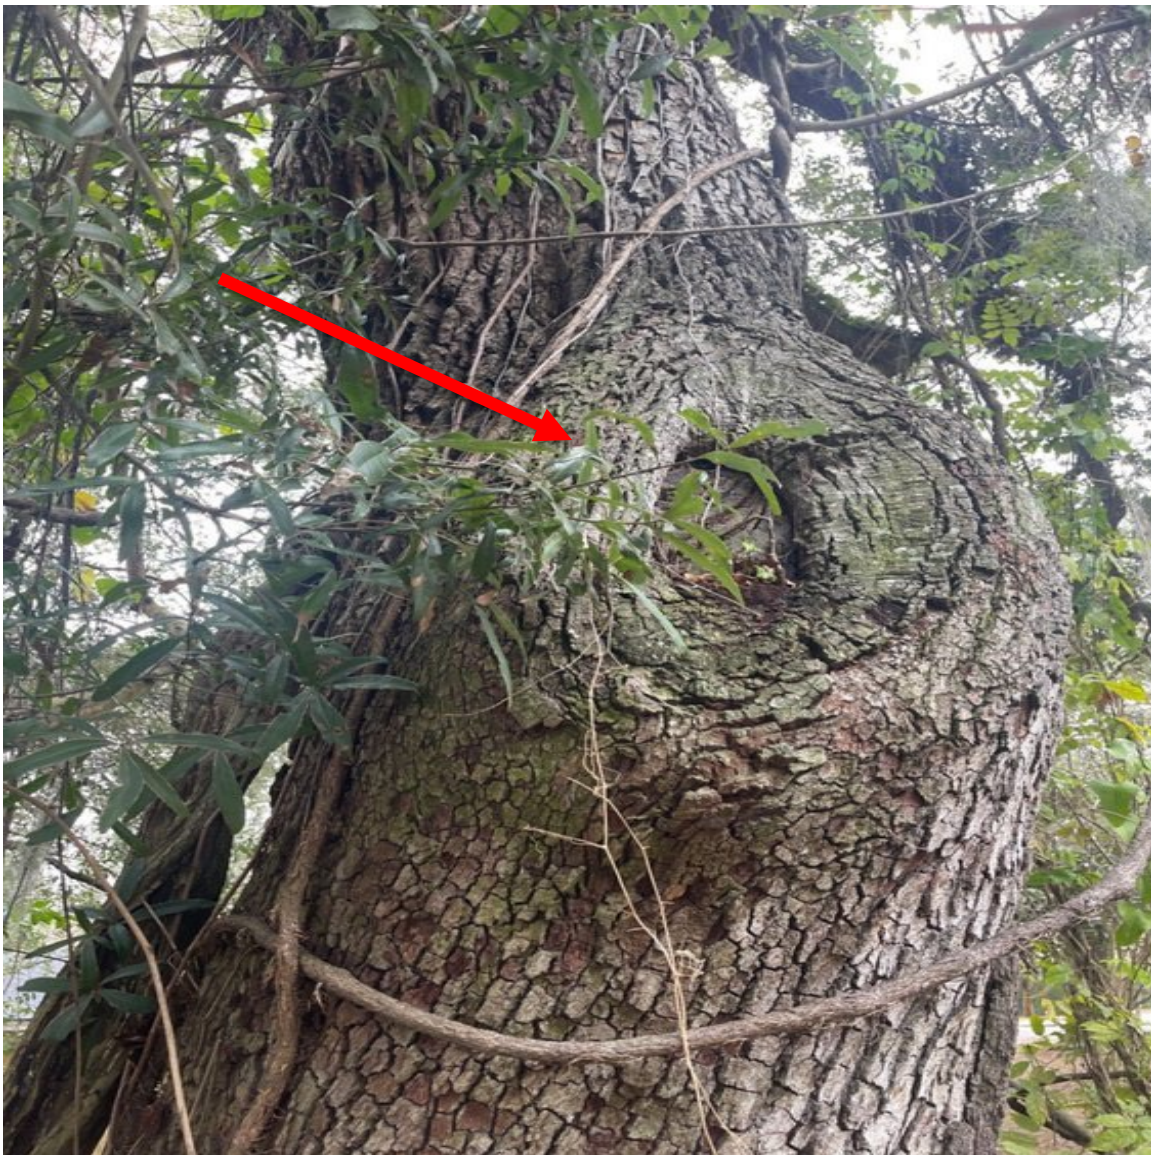
Figure 5: Decay in a very large branch collar from a stem removed many years earlier.

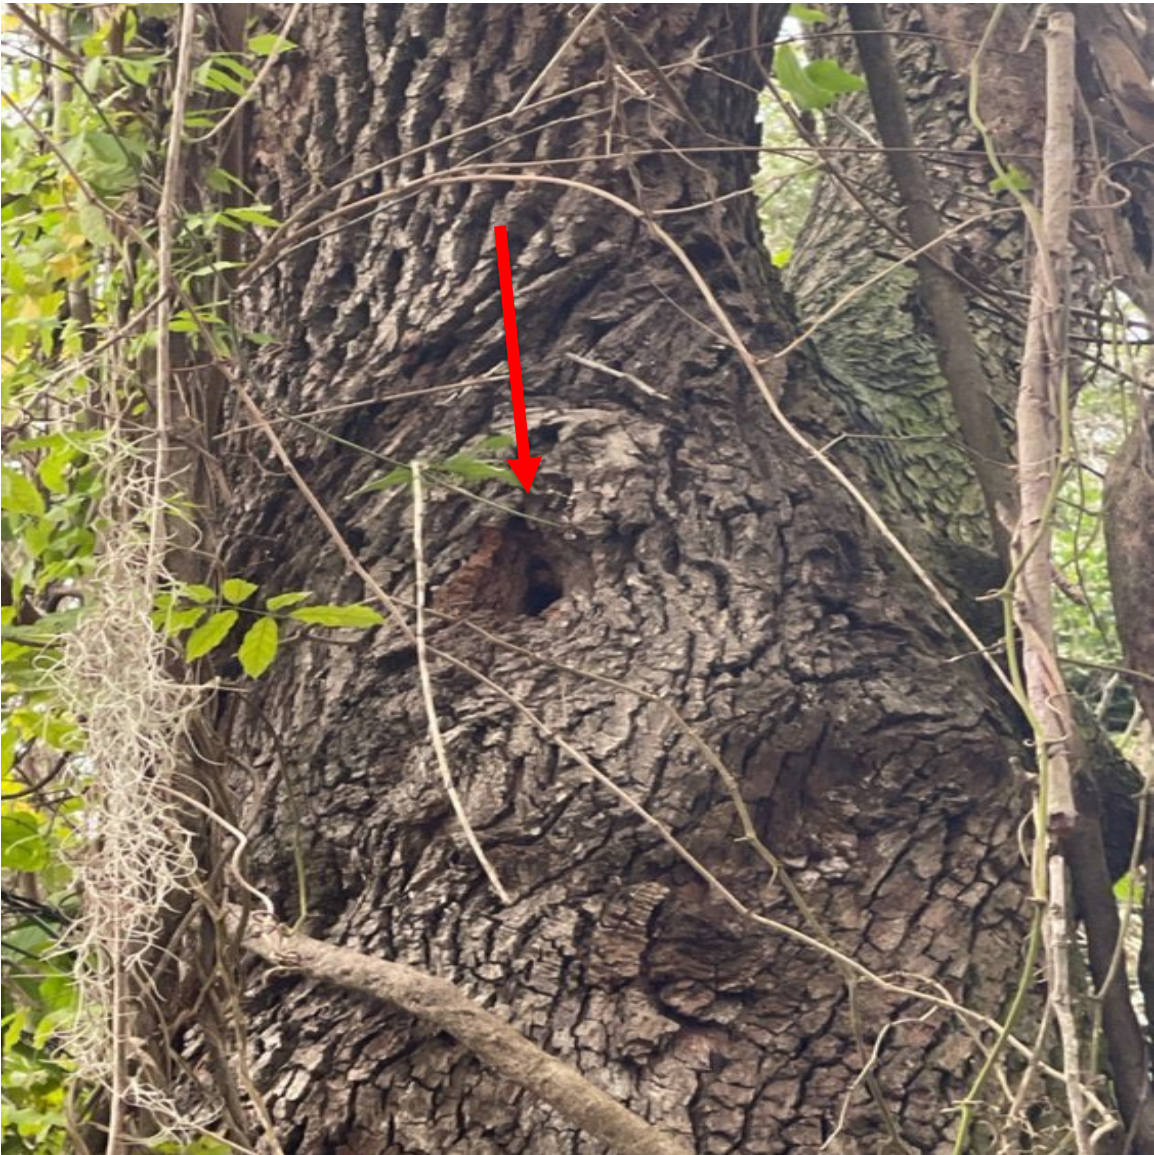
Figure 6: This wound contains a deep cavity which opens to a larger chamber inside the trunk of the tree.

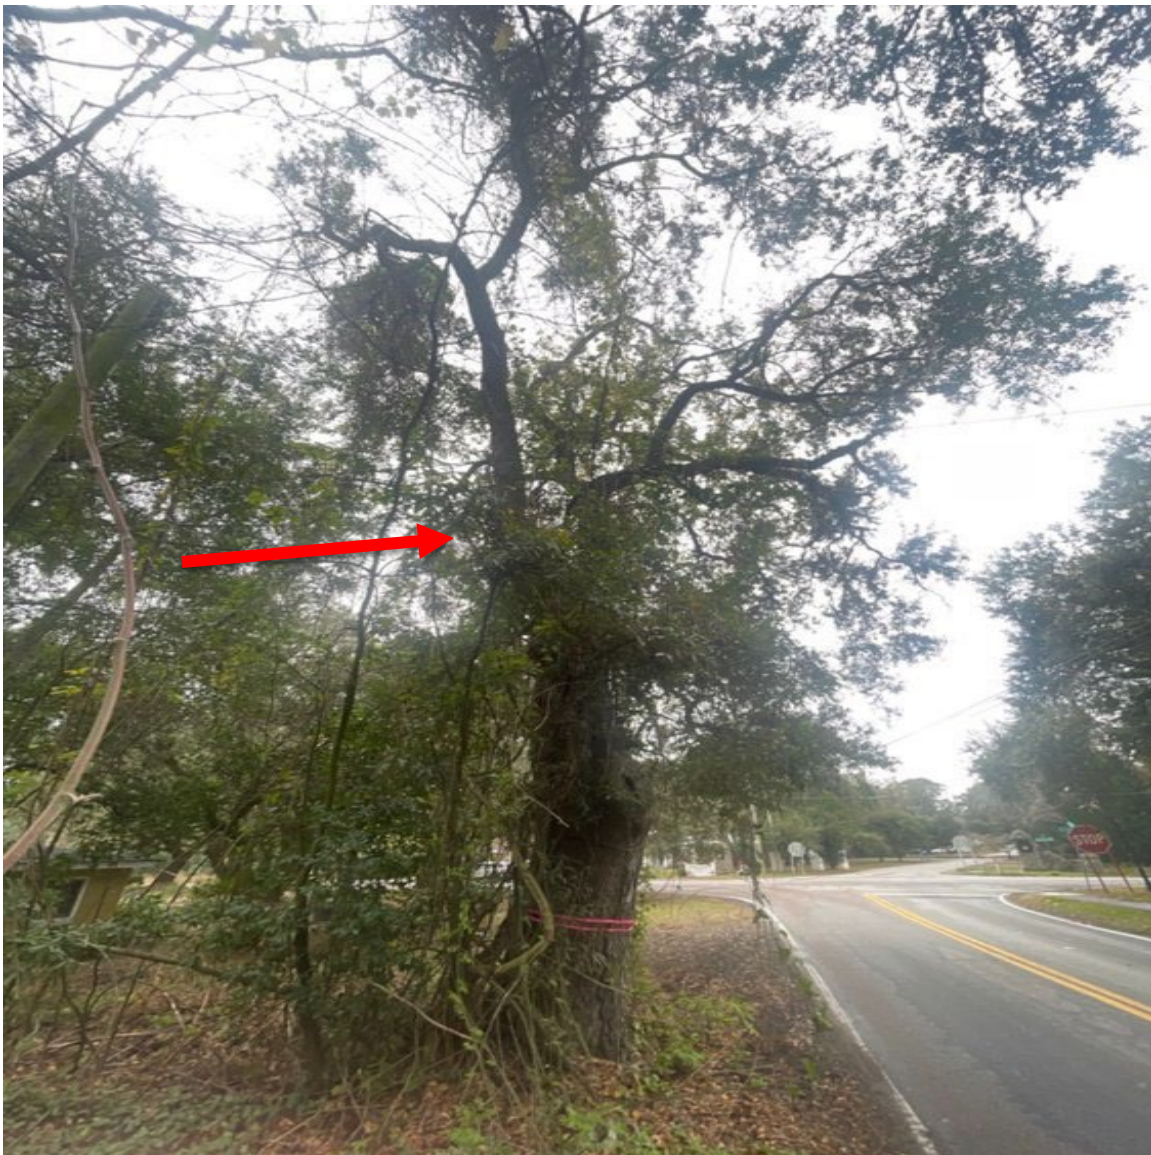
Figure 7: Severe vine saturation.

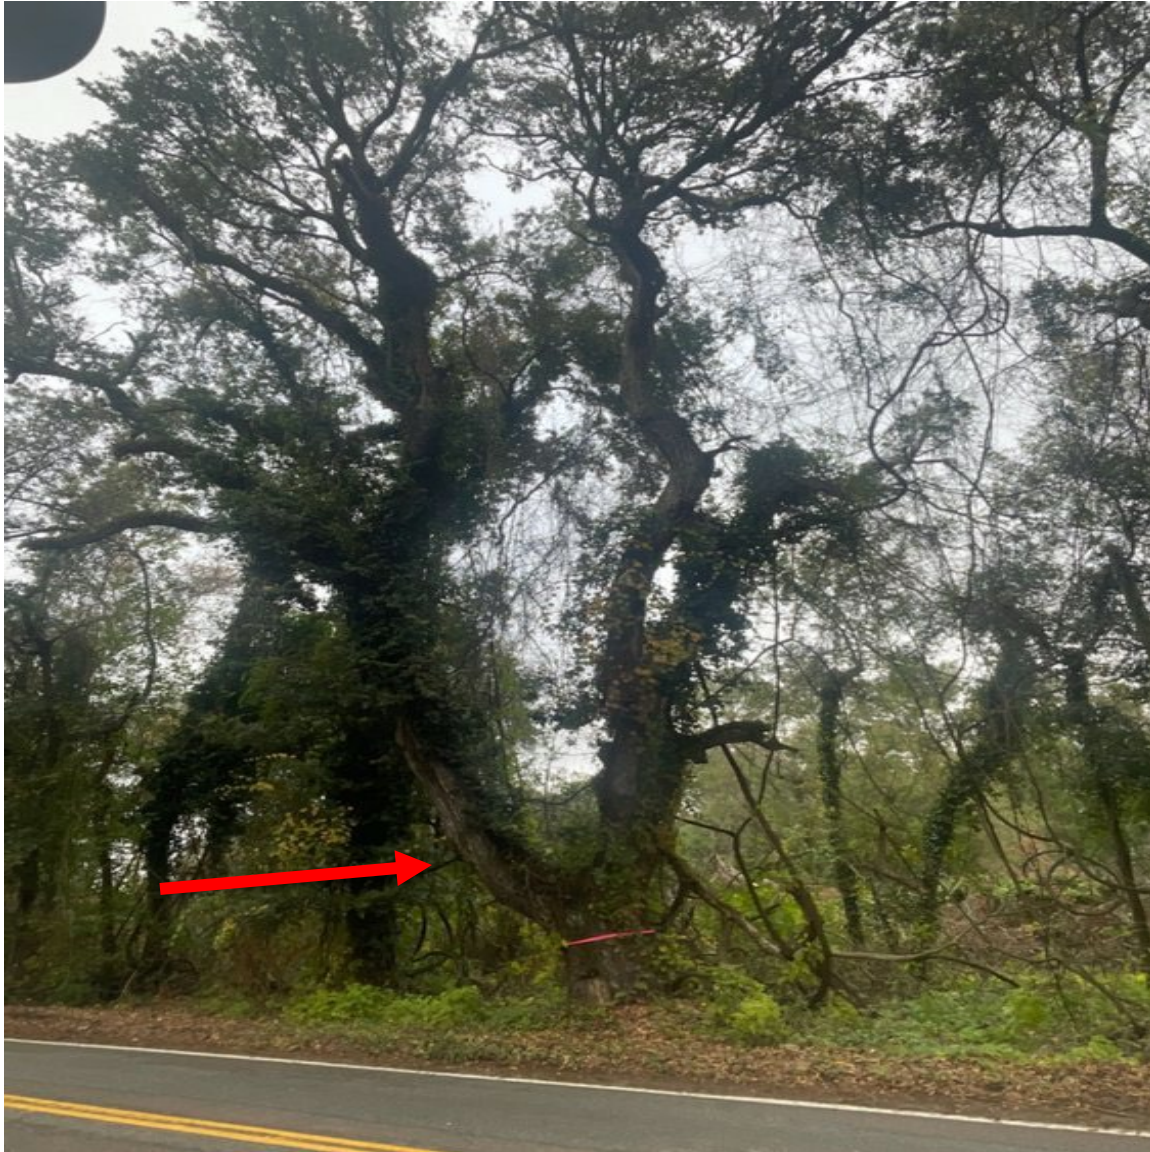
#2 LIVE OAK, *QUERCUS VIRGINIANA*

The adjacent Live oak (Tree #2), measuring 44", is also located extremely close to the asphalt of the North side of Camp Road. Upon inspection, I found it to be in an even worse condition than Tree #1. Extensive root collar damage and a large cavity of decay at the root collar with a white-rot pathogen present were noted. White-rot fungi degrades the heartwood's lignin, a key structural element, causing it to be bleached and become soft and sponge-like. White-rot is among the most aggressive types of wood decay pathogens. It advances through the heartwood of the tree thereby causing structural compromise and ultimately resulting in a whole tree mechanical failure. Multiple cavities of decay in large leaders present weak points vulnerable to fracturing. Of additional concern was a co-dominant stem with a cavity of decay loading toward the roadway. The tree had numerous large, failed limbs, overall canopy die-back and severe vine saturation. The vine presence made it difficult to inspect the entire canopy and I suspect additional defects are present. The tree will not sustain through the proposed construction impacts. As is, the tree is steadily declining, has a high risk of mechanical failure and poses a hazard to life and property within 1x its height.

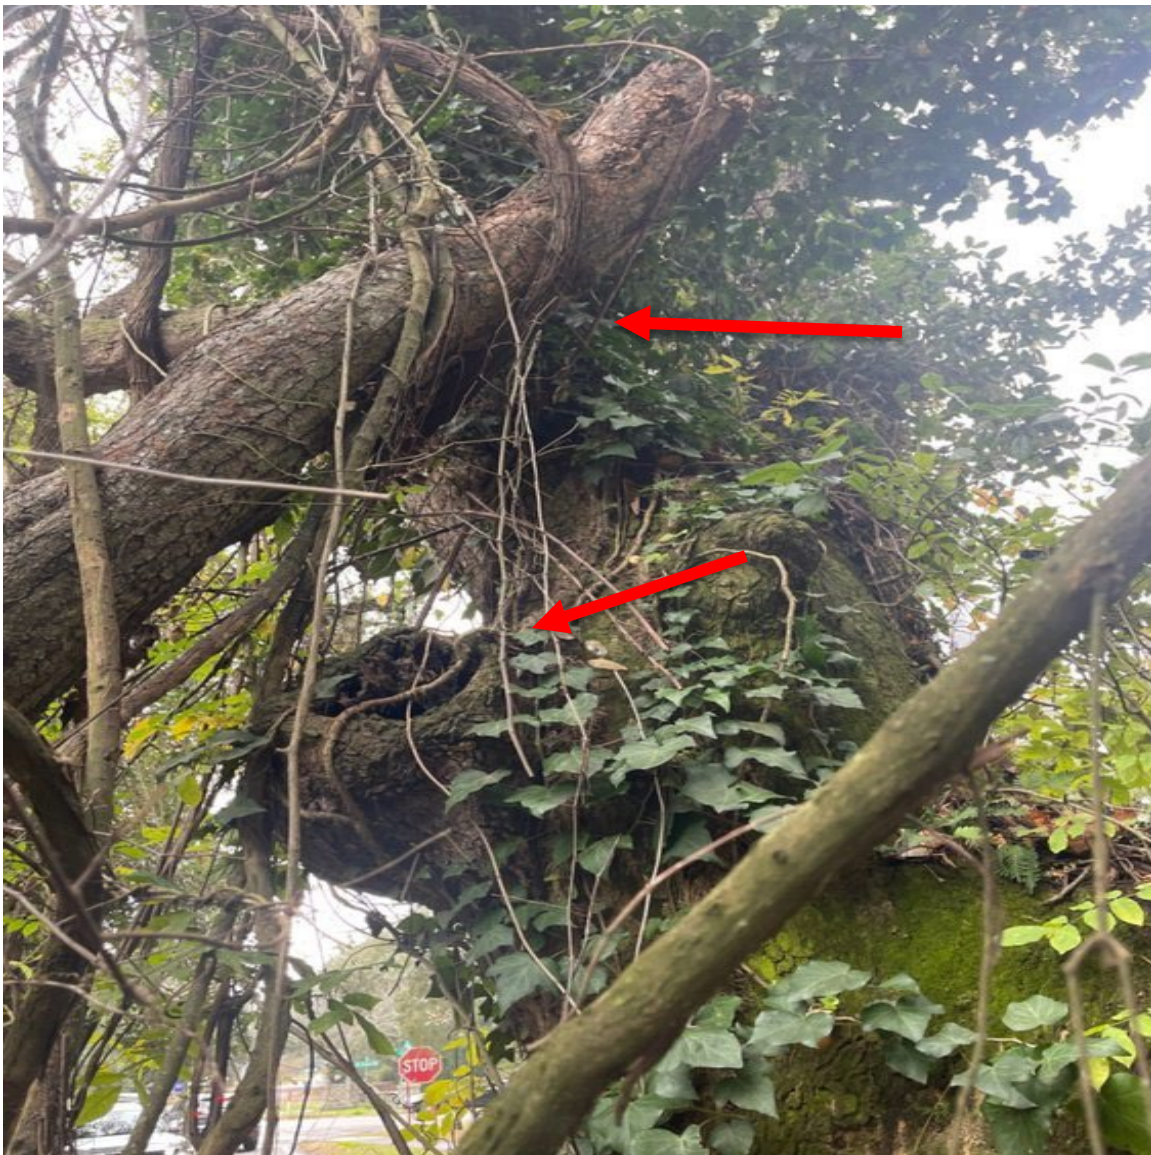
Figure 8: In this image we find the remnants of a large storm-damaged branch hanging in the vines above and an older branch collar on the trunk column exhibiting severe decay and rot.

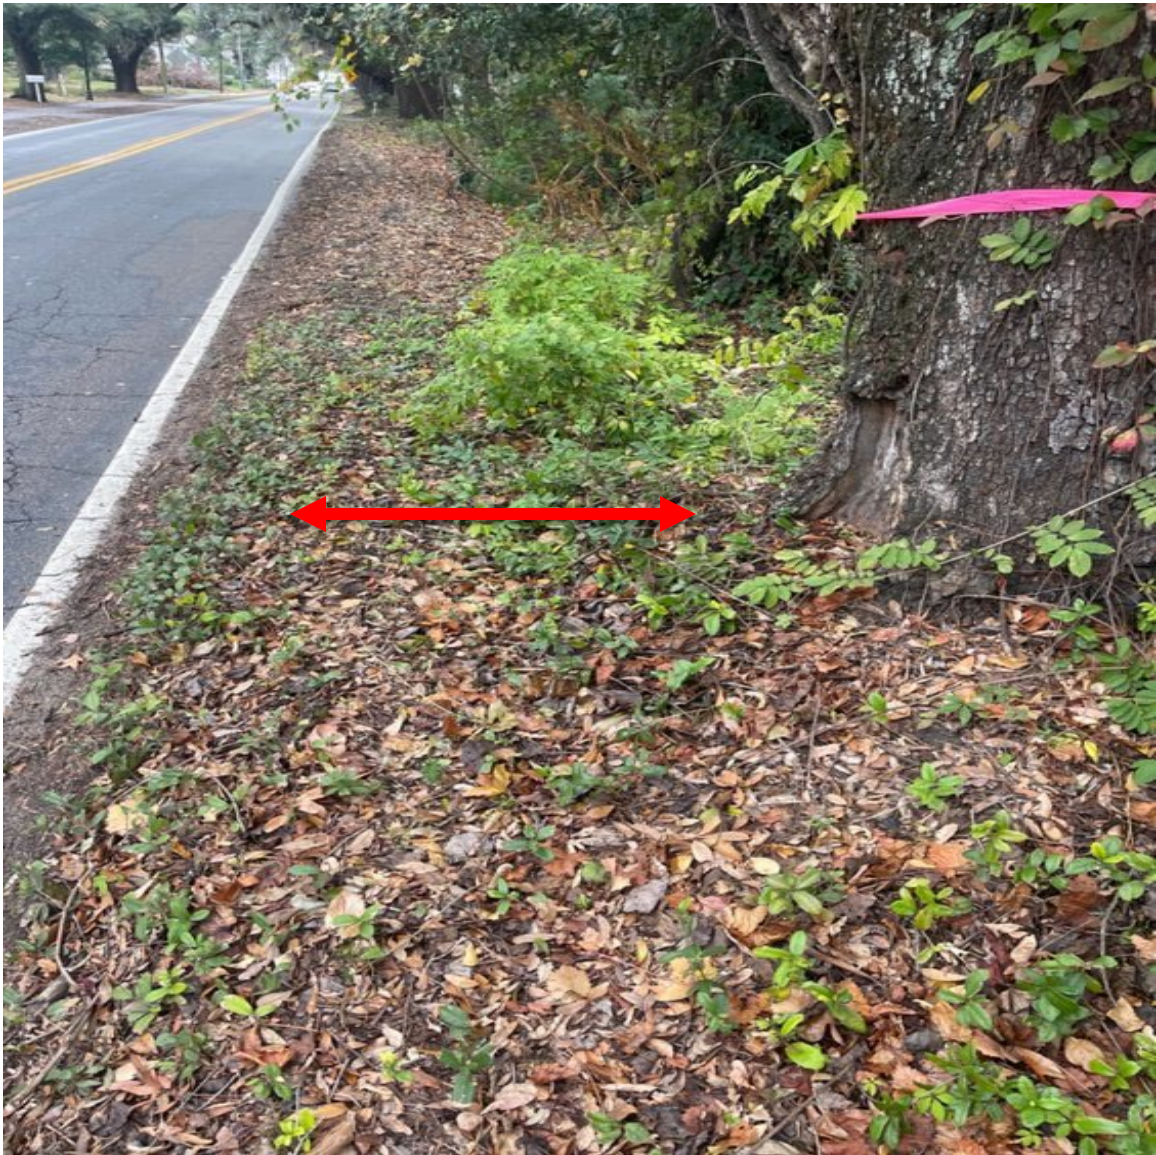
Figure 9: The root collar of this tree is approx. 4 ft from the asphalt edge of the roadway. This would mean that a significant area of the critical root zone and root plate are located beneath the roadway.

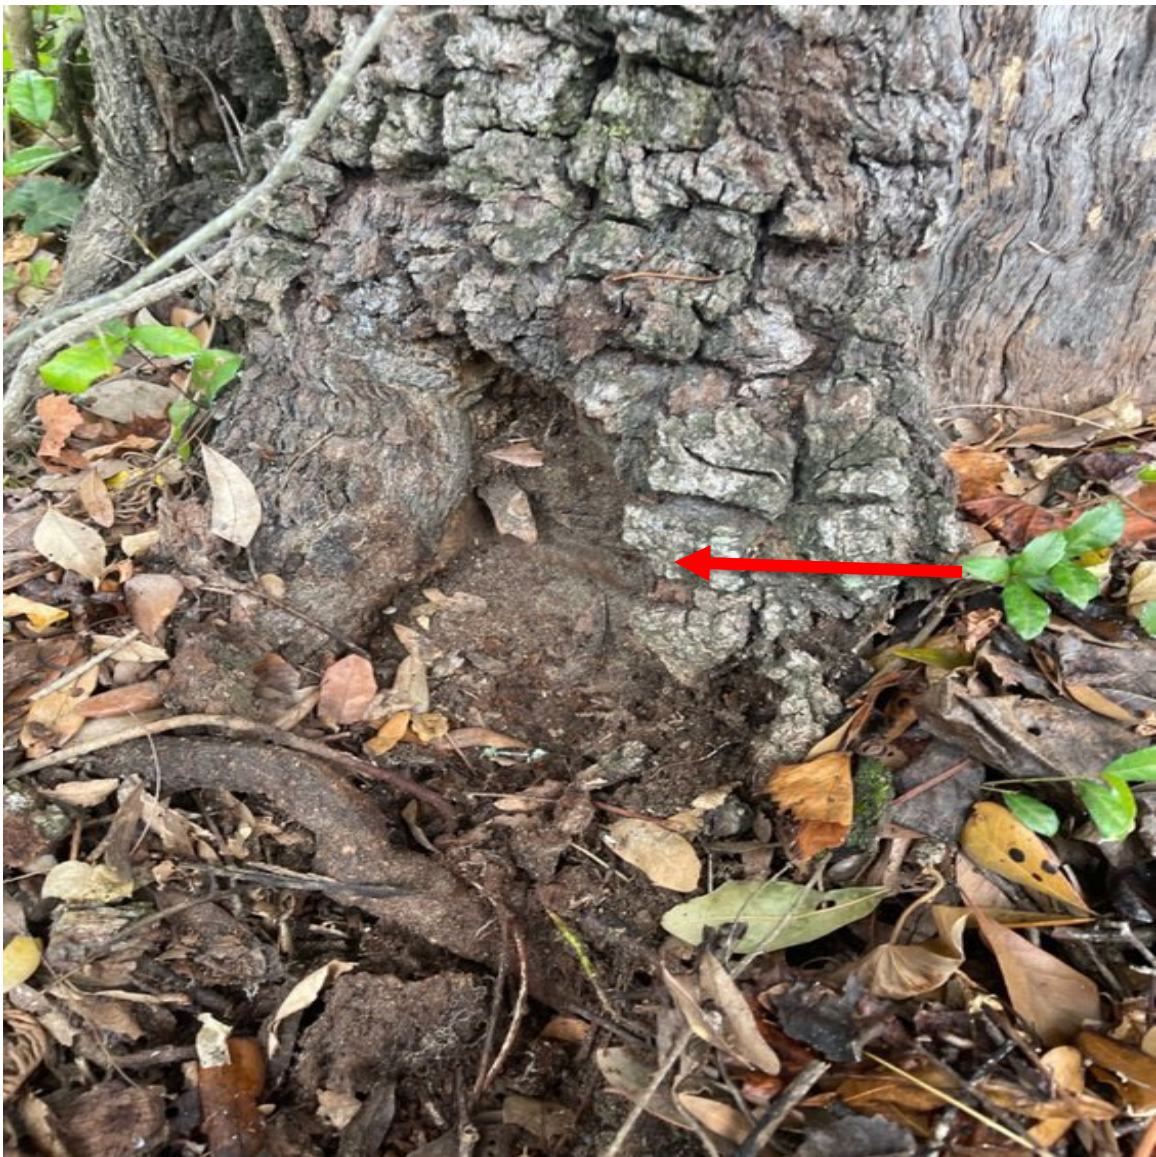
Figure 10: Decay and rot found in one of the buttress roots from a prior injury.

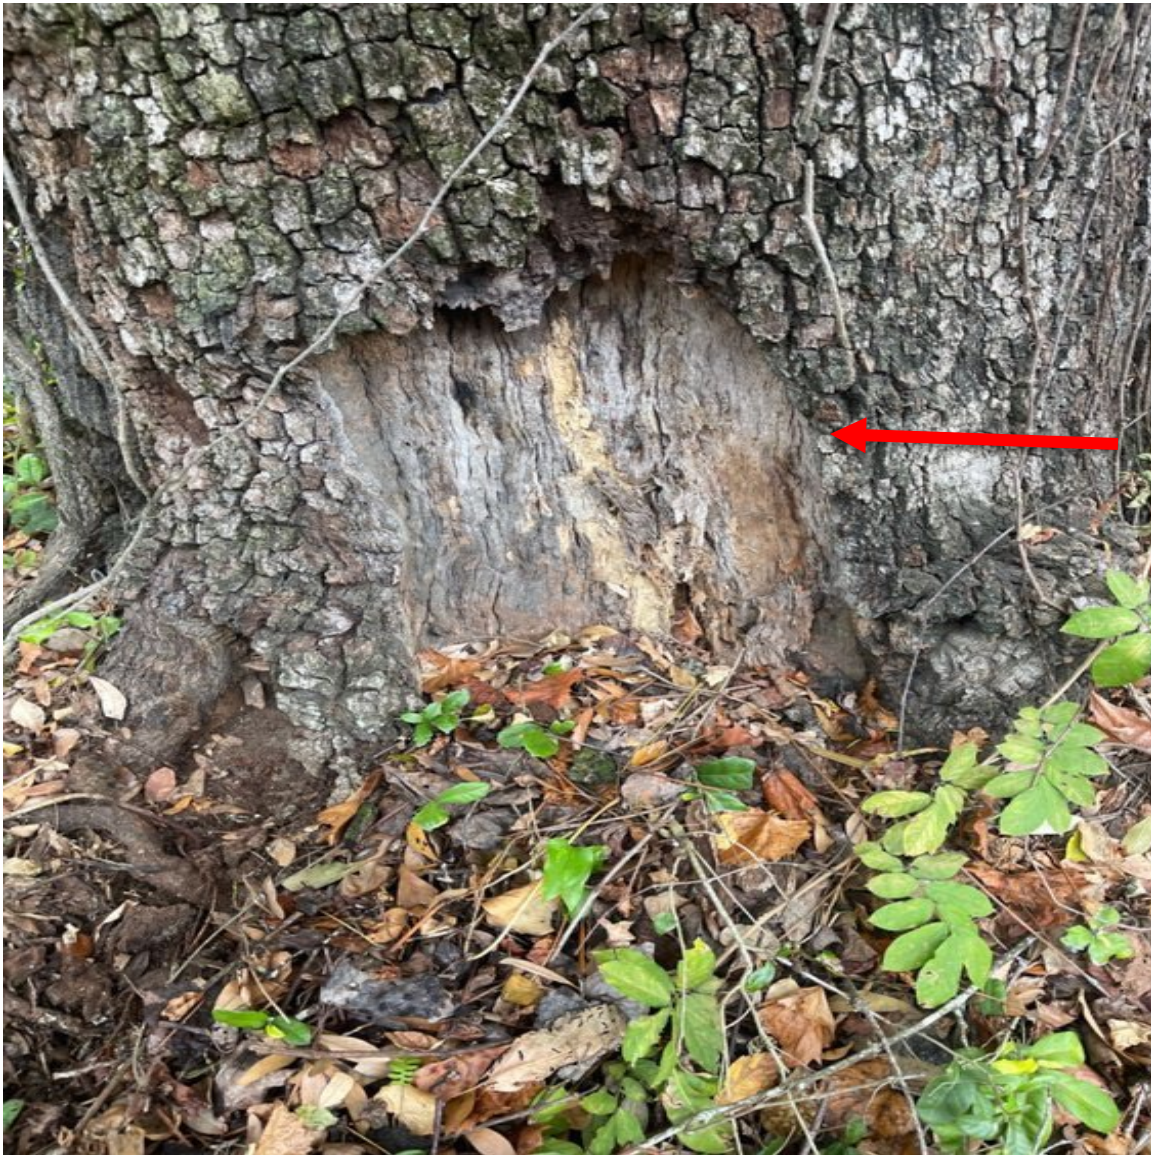
Figure 11: Basal injury just above the root collar caused by an unknown mechanical injury.

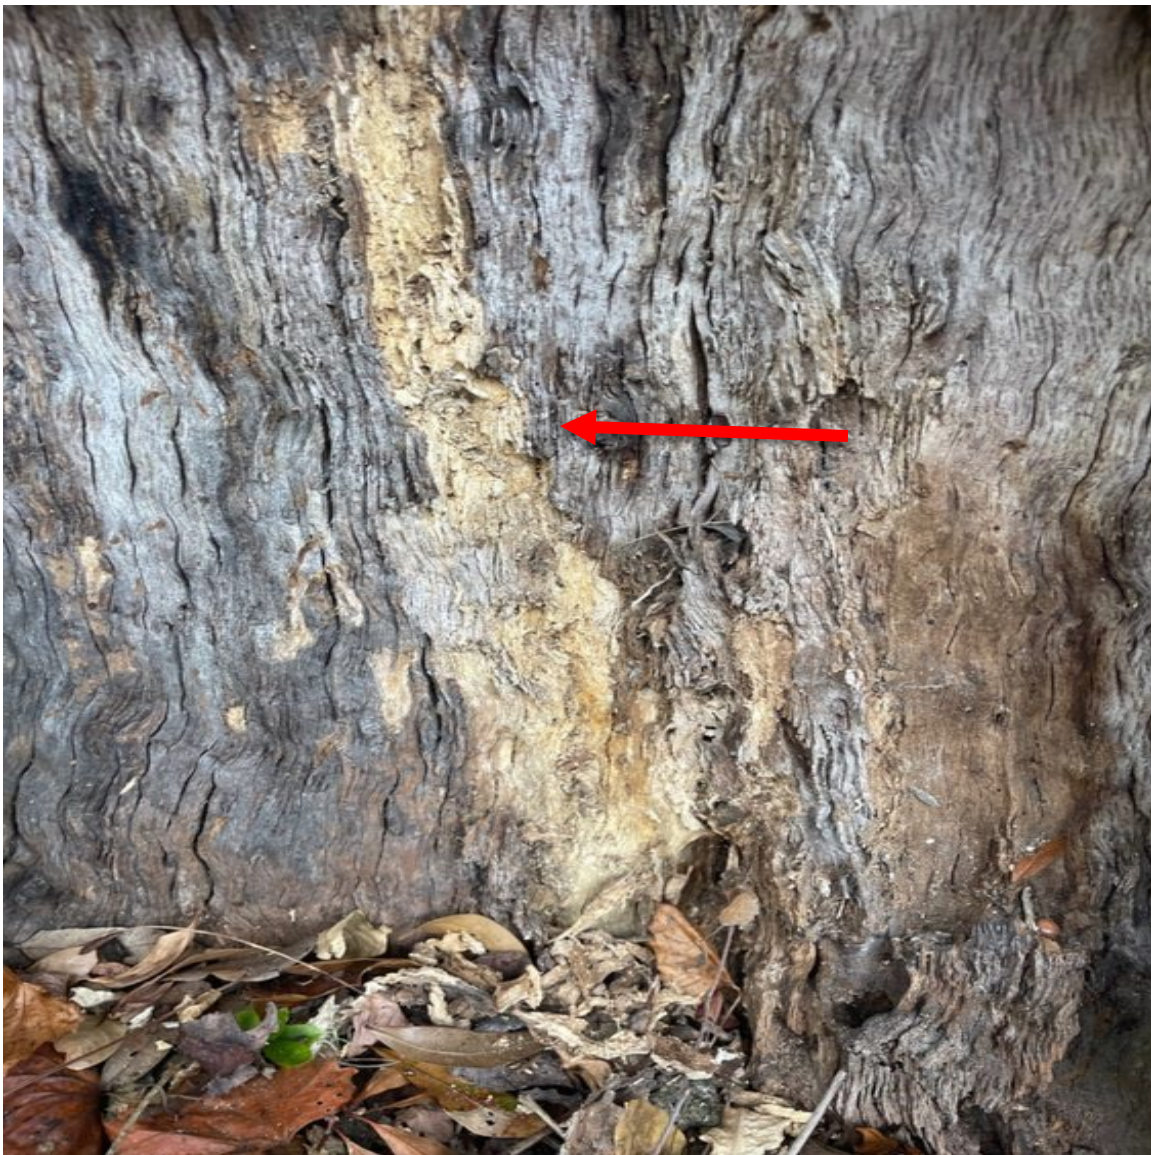
Figure 12: This wound is harboring a white-rot wood decay pathogen, most likely *Armillaria* spp based on the bleaching of the wood and corky composition.

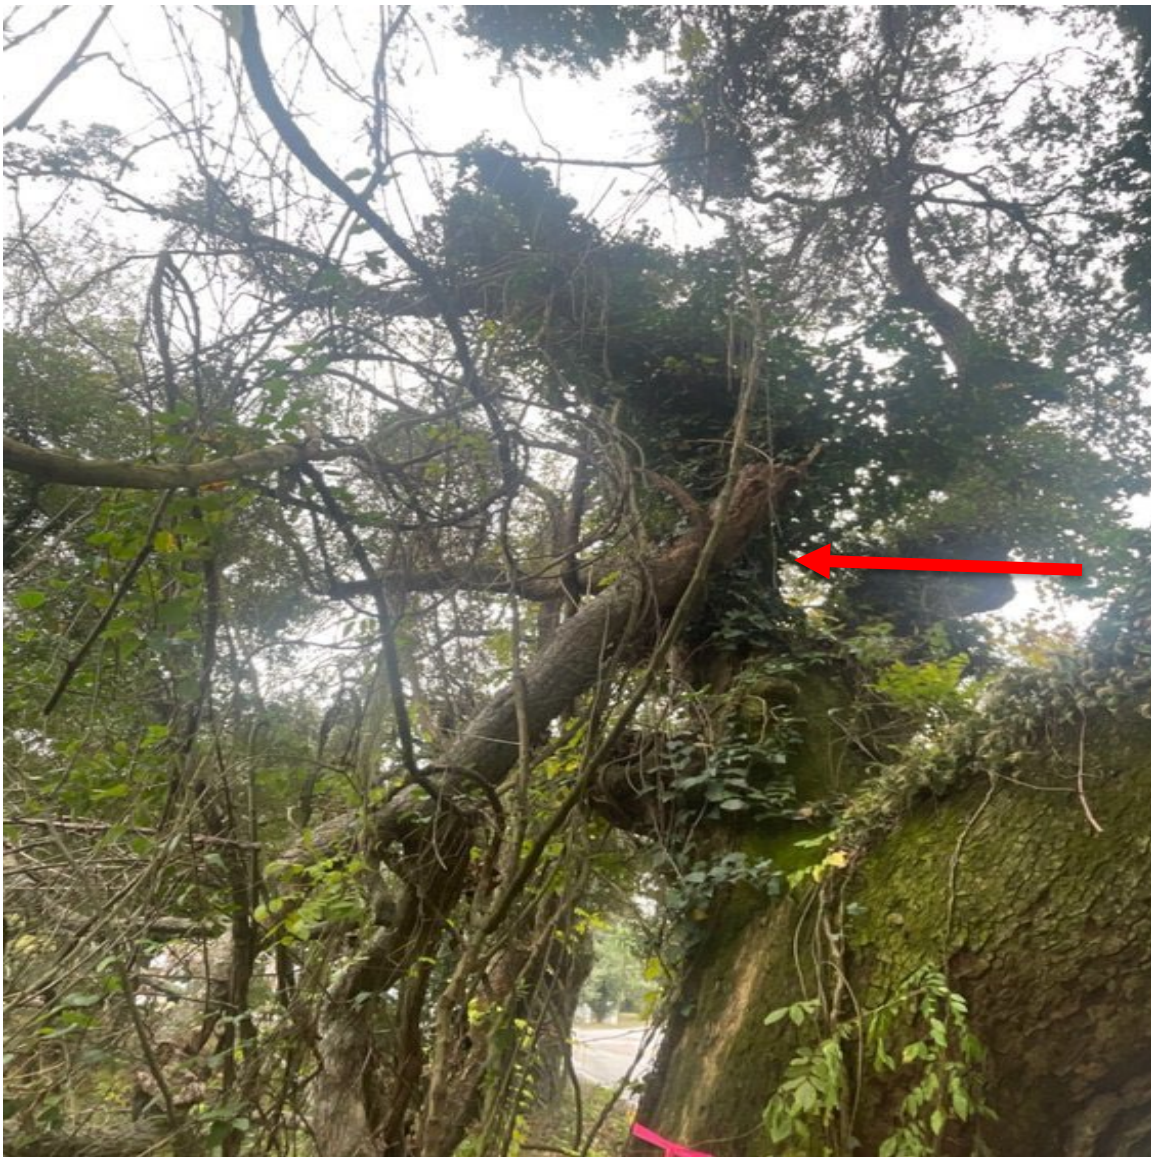
Figure 13: Storm-damaged branch, vine saturation likely contributed to this failure.

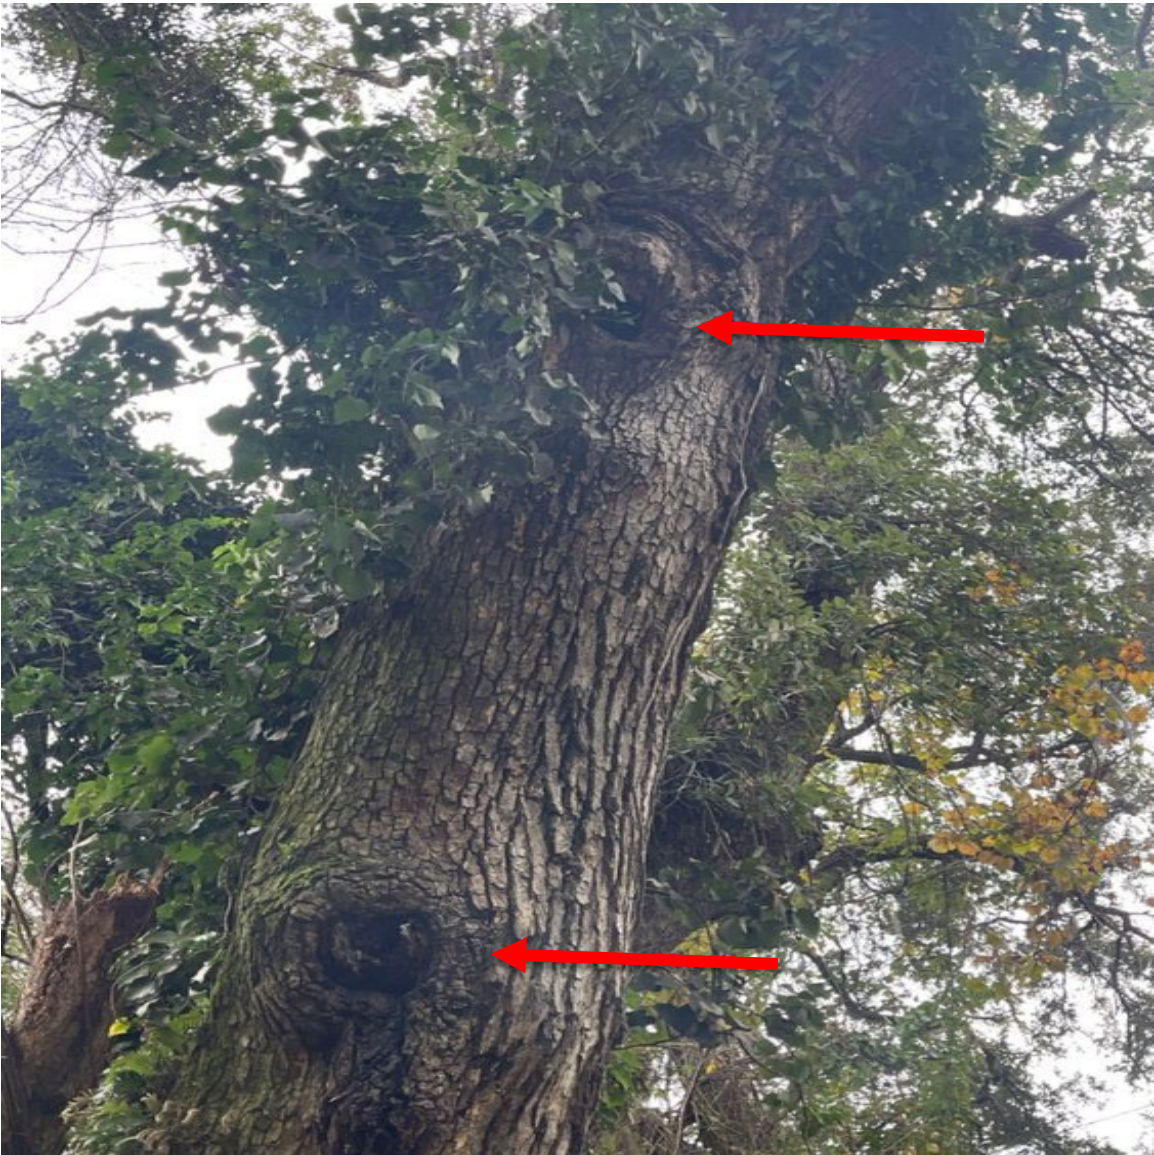
Figure 14: Two very large cavities with rot contained in one of the primary stems approx. 15 and 20 ft above ground level.
