TREE RISK ASSESSMENT

Camp Road (S-28) at Intersection of Fort Johnson Road (S-94)
Charleston, SC 29412

Don Alexander
Parrish and Partners

January 08, 2023

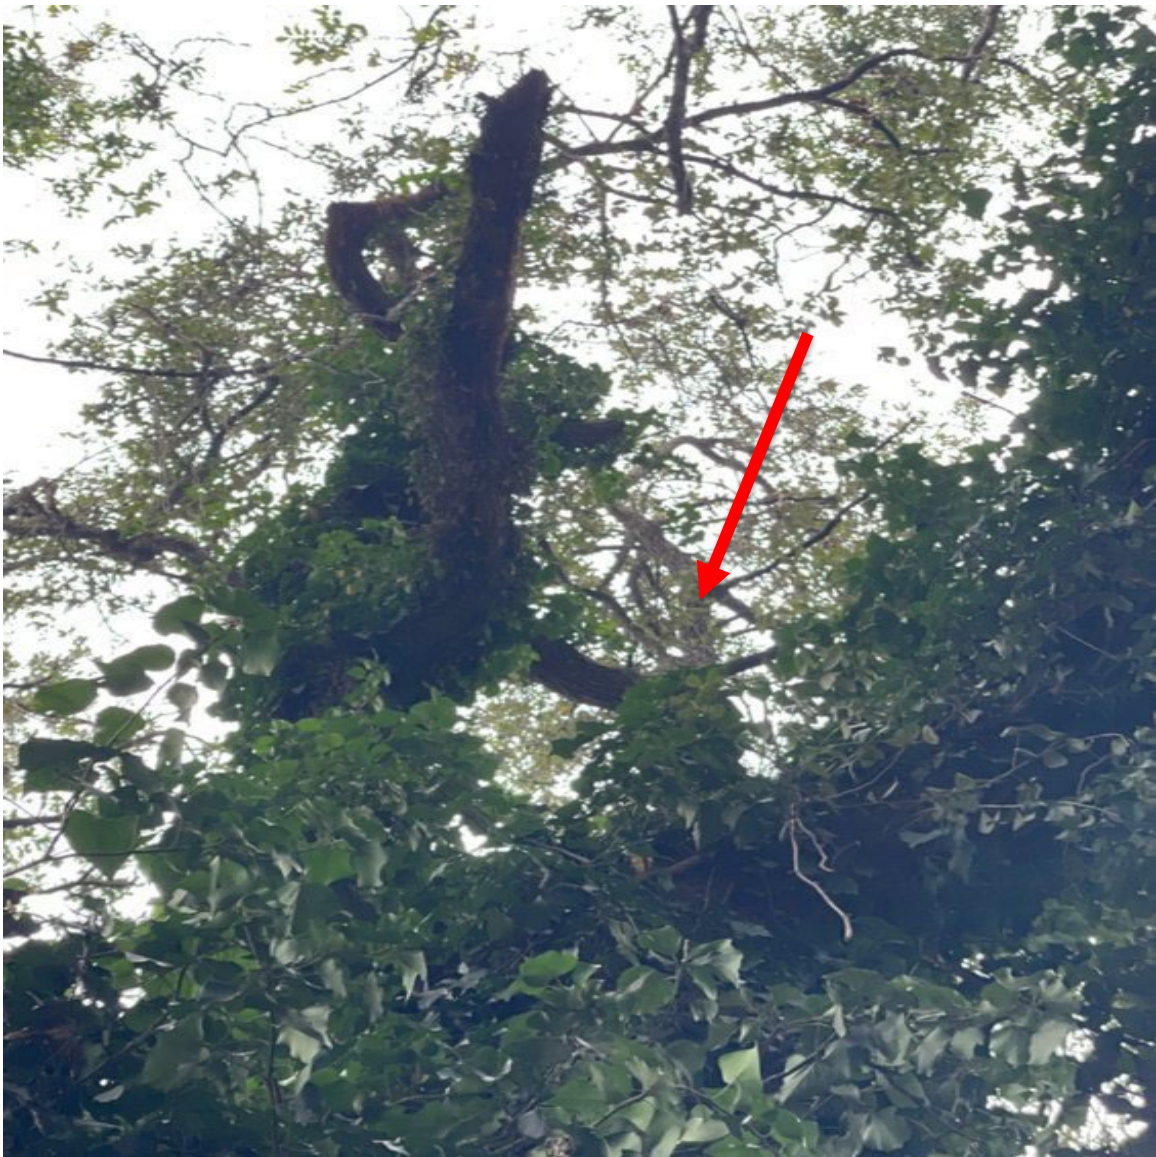
Figure 15: Severe vine saturation throughout the canopy.

Trees #1 and #2: Do not cater plans to retain these trees. Complete removal utilizing ANSI A300 Standards for Tree Care Operations.

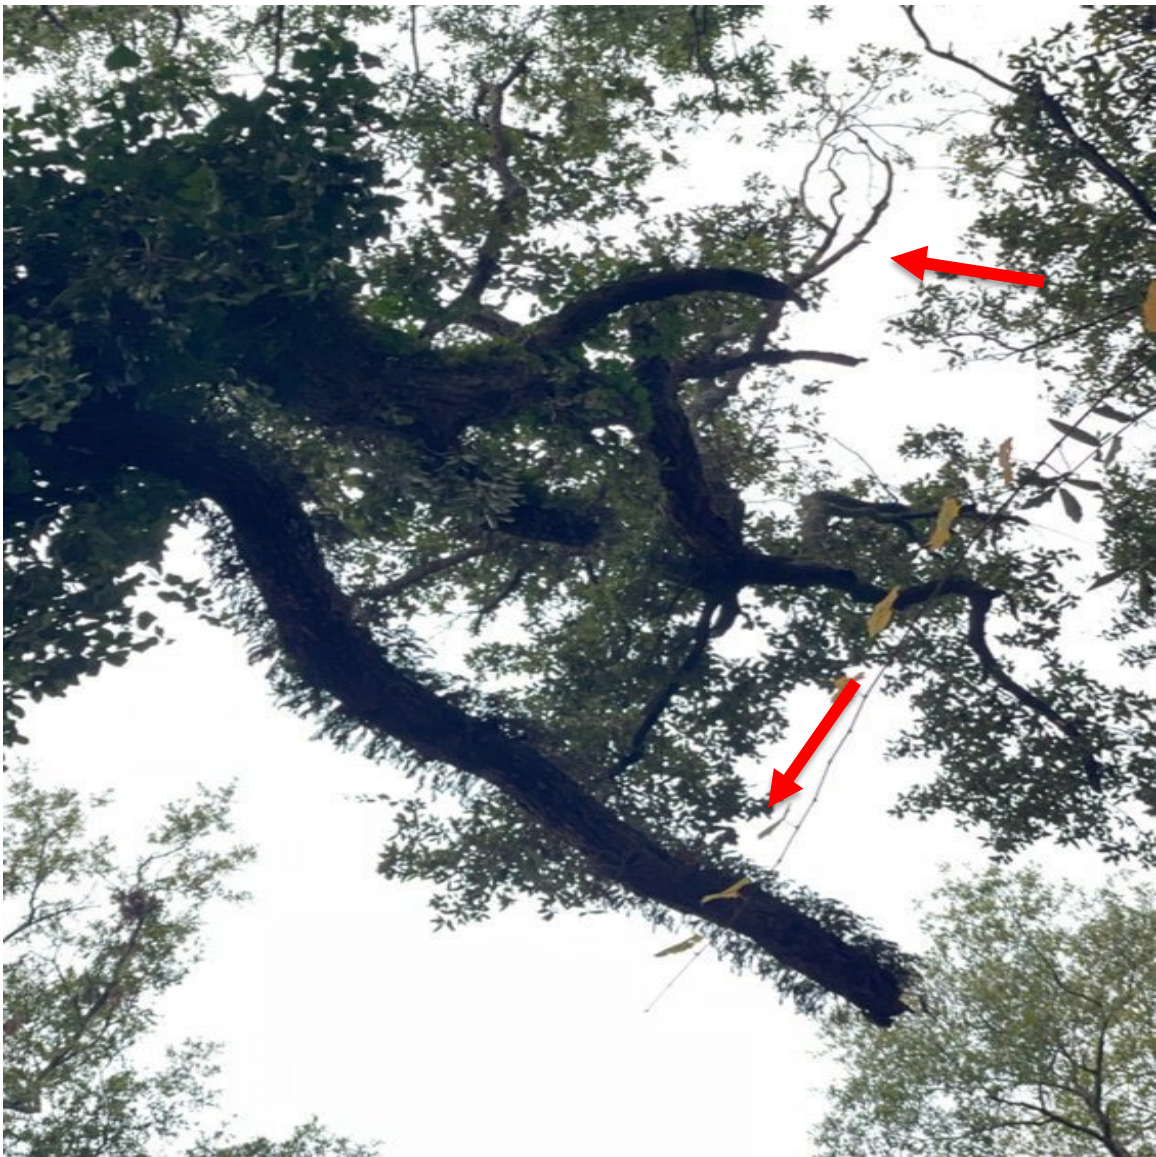
Figure 16: Numerous large dead branches overhanging the roadway.

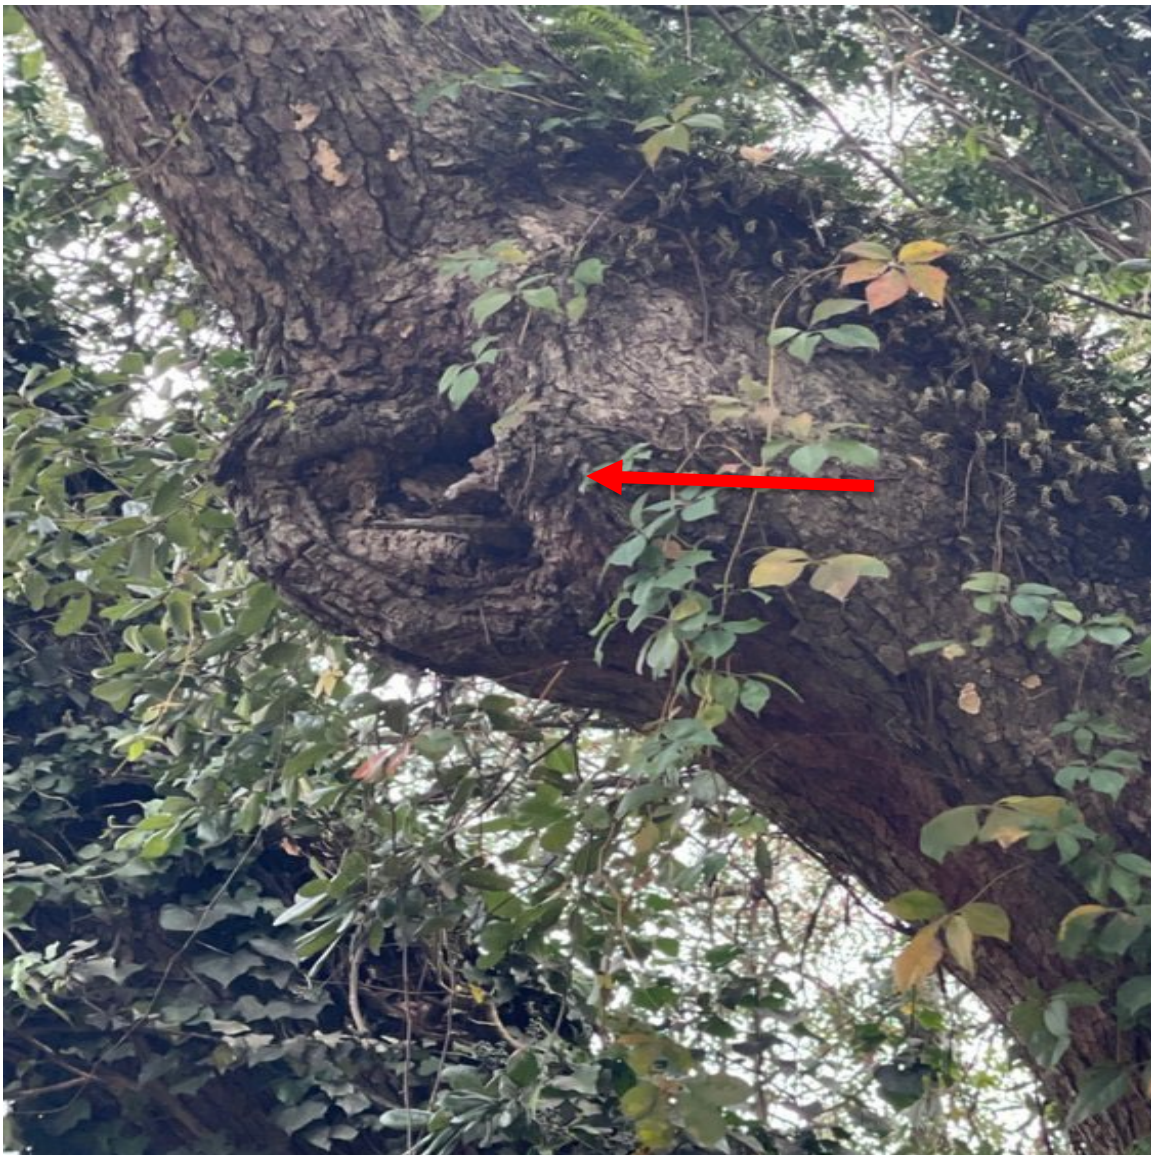
Figure 17: A very large wound with rot in the secundar primary stem.

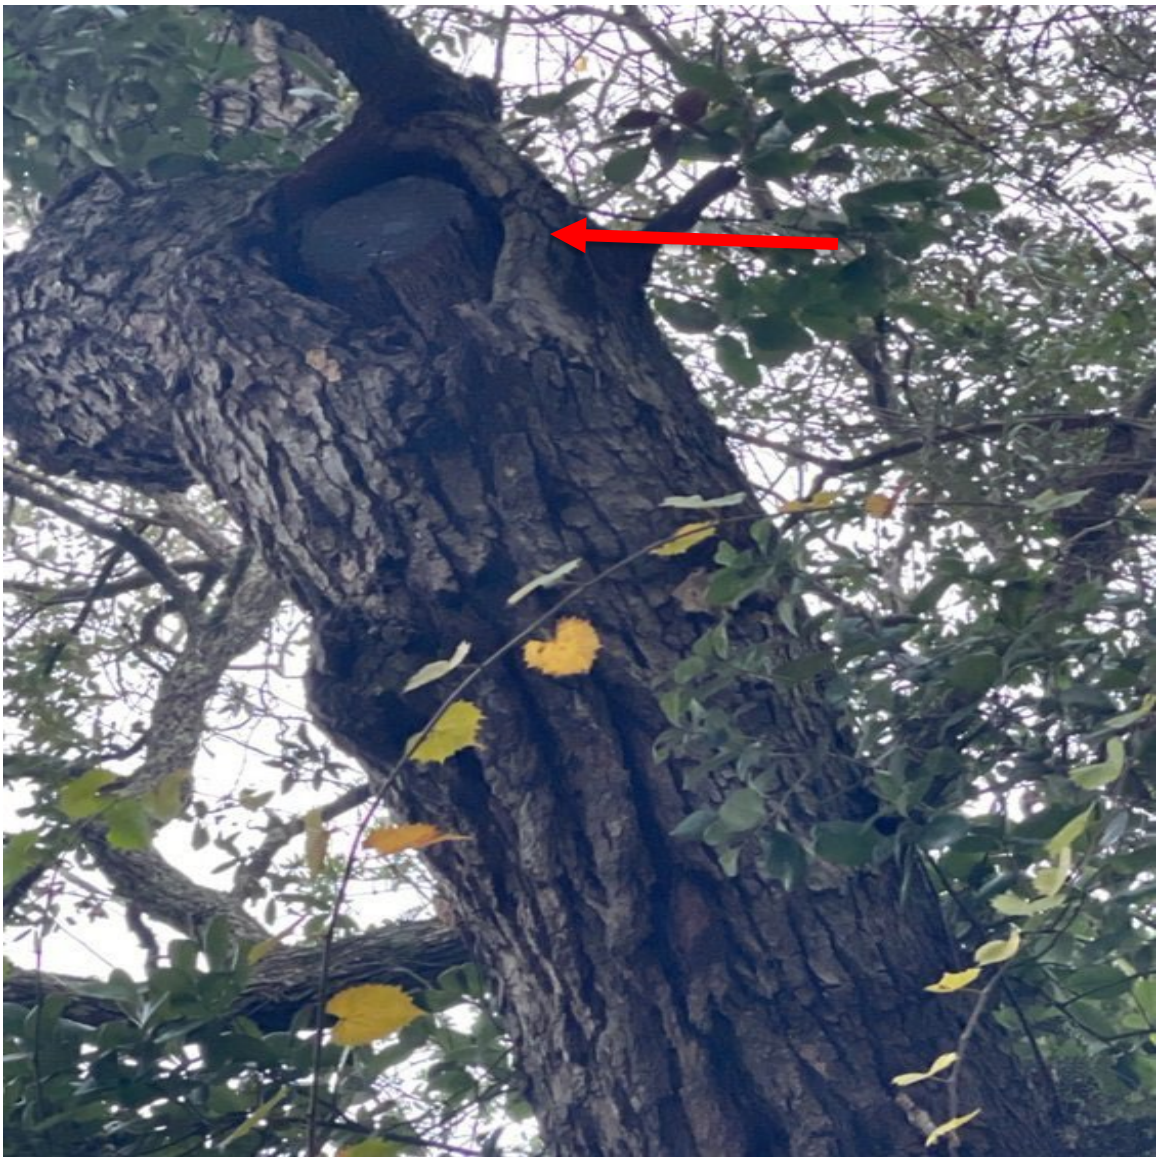
Figure 18: Another wound with rot in the secondary primary stem.

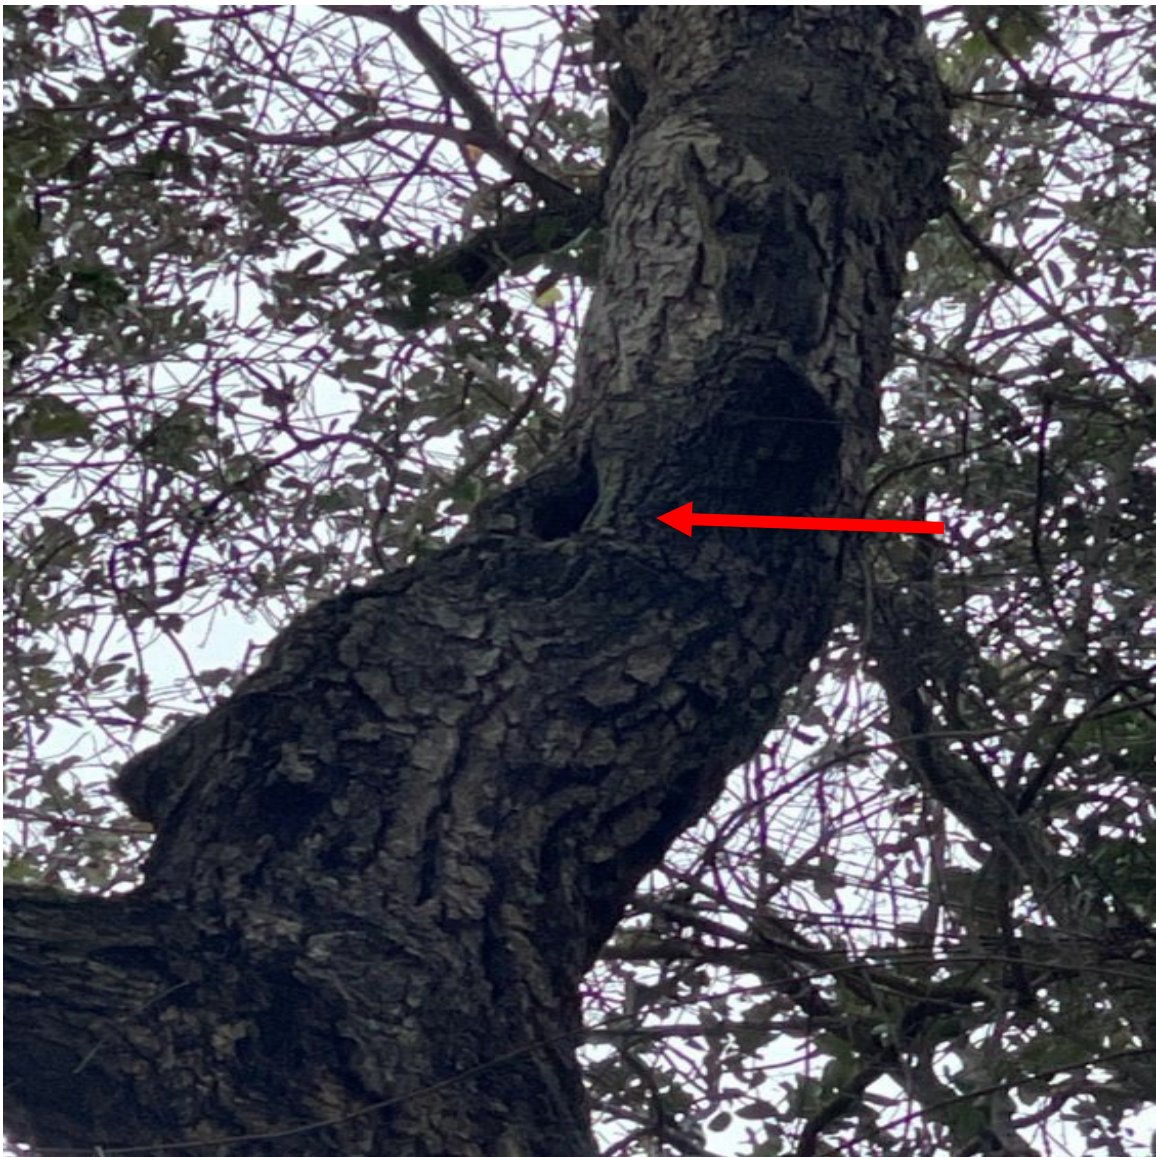
Figure 19: Another cavity with decay located in the upper canopy. This cavity appears to be 1 ft in depth.

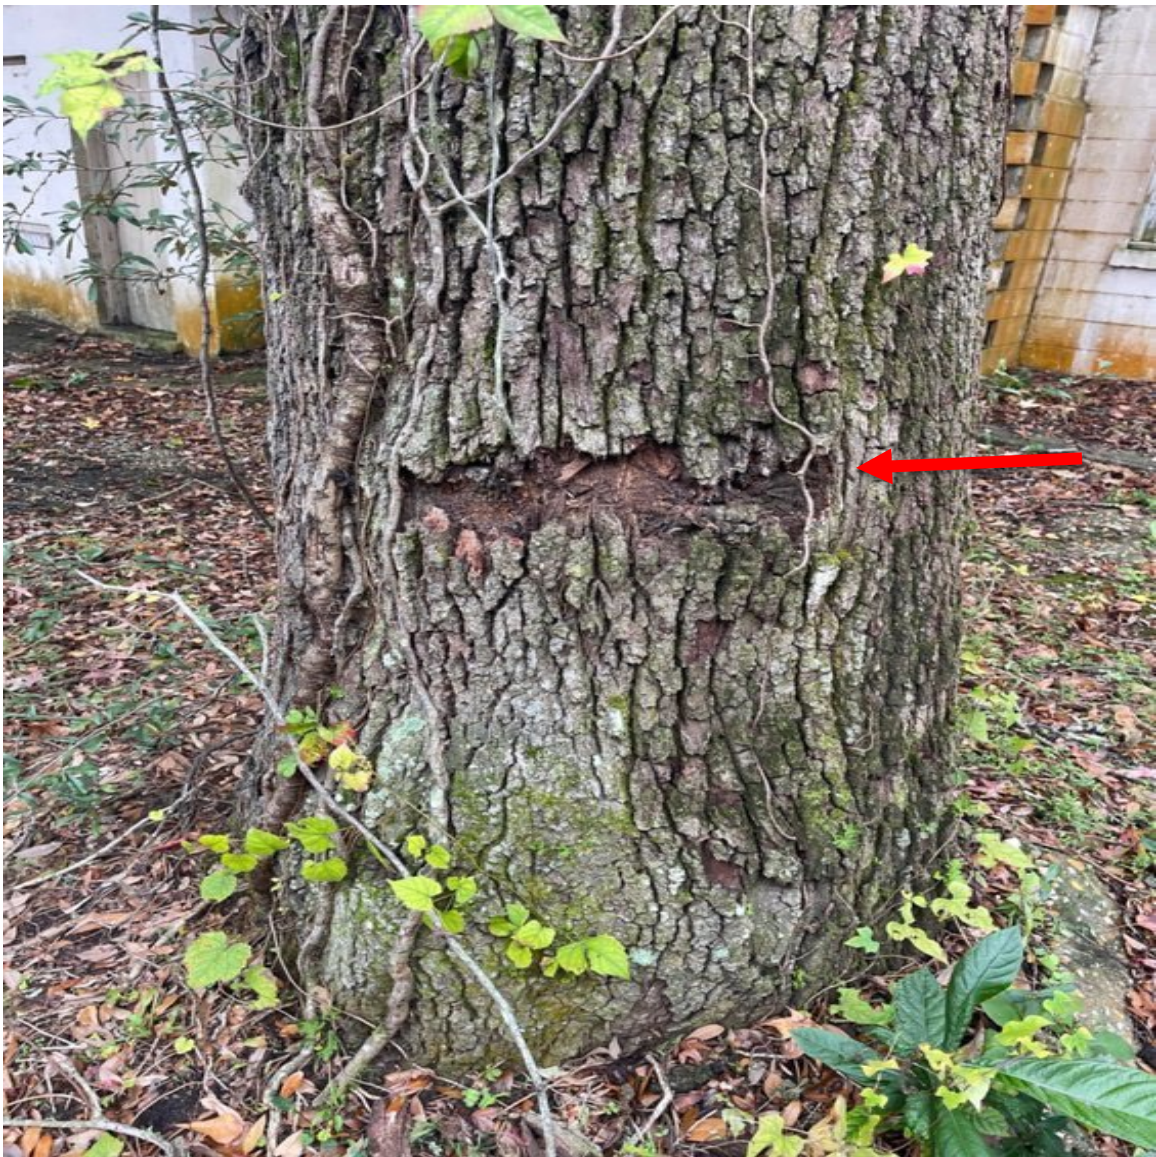
Figure 20: Minor mechanical injury to the base of the trunk column.

Tree #3: Cater construction plans for the preservation and retainment of Tree #3. Enact an adequate Tree Preservation Plan, and prune to remove dead limbs 1" in diameter and greater to reduce risk.

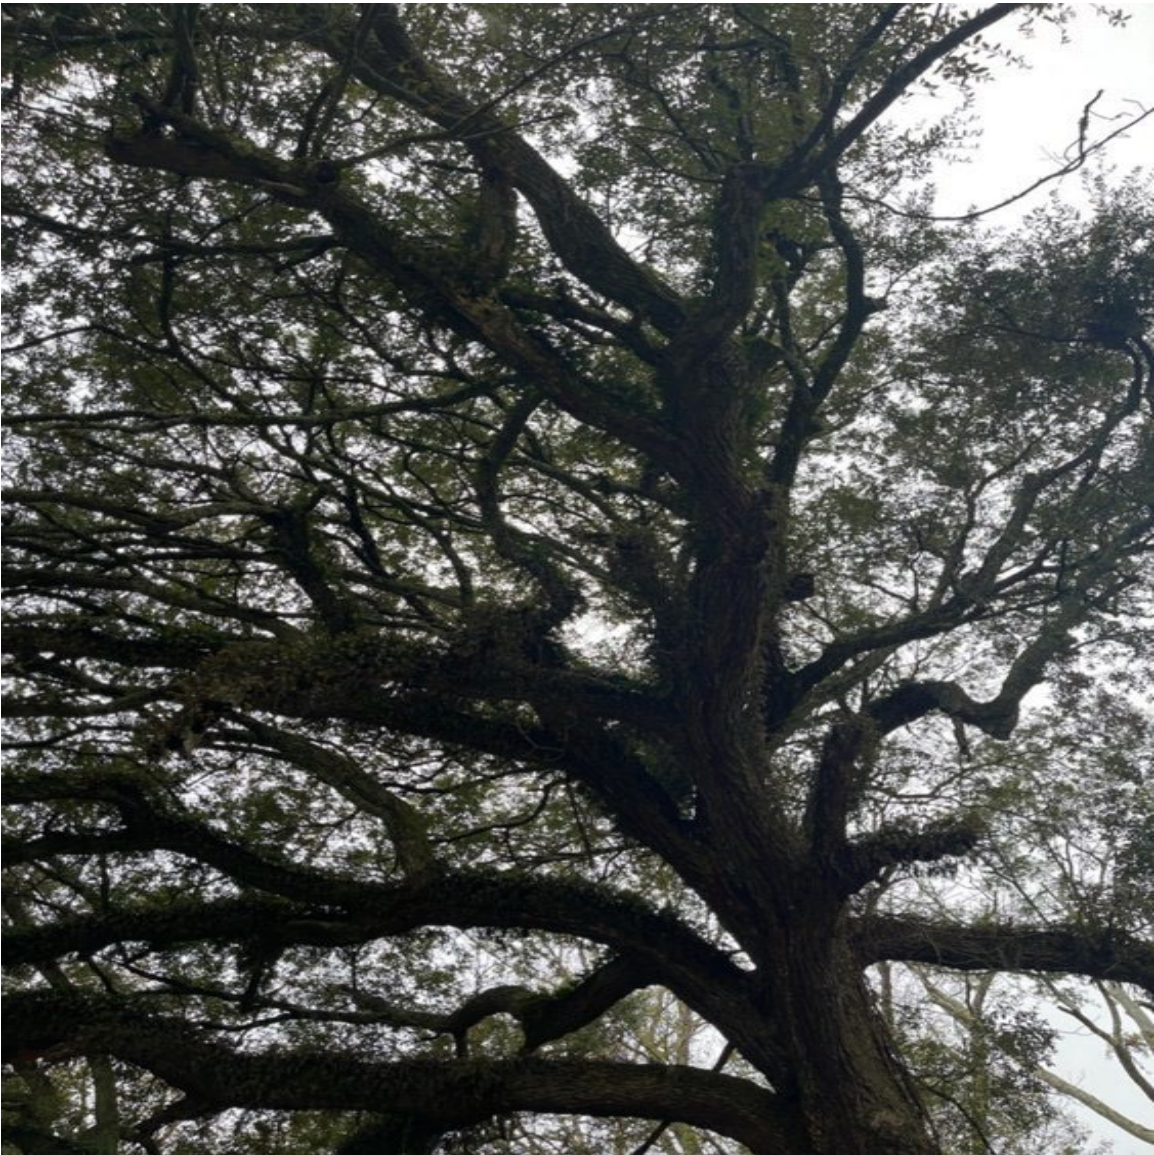
Figure 21: Lots of minor deadwood throughout the canopy.

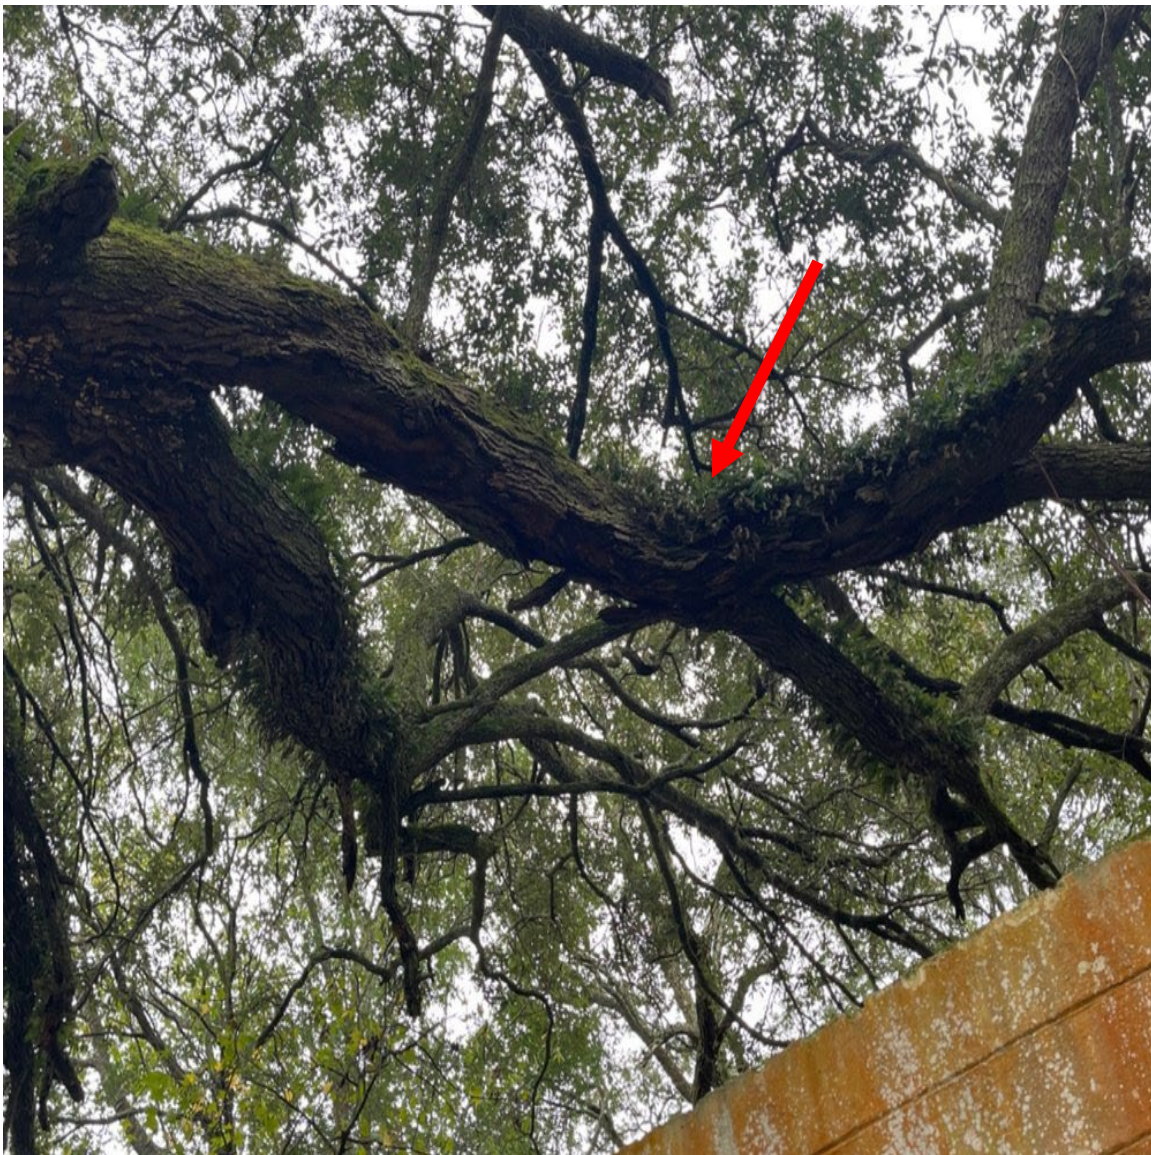
Figure 22: Bark canker found on several stems.

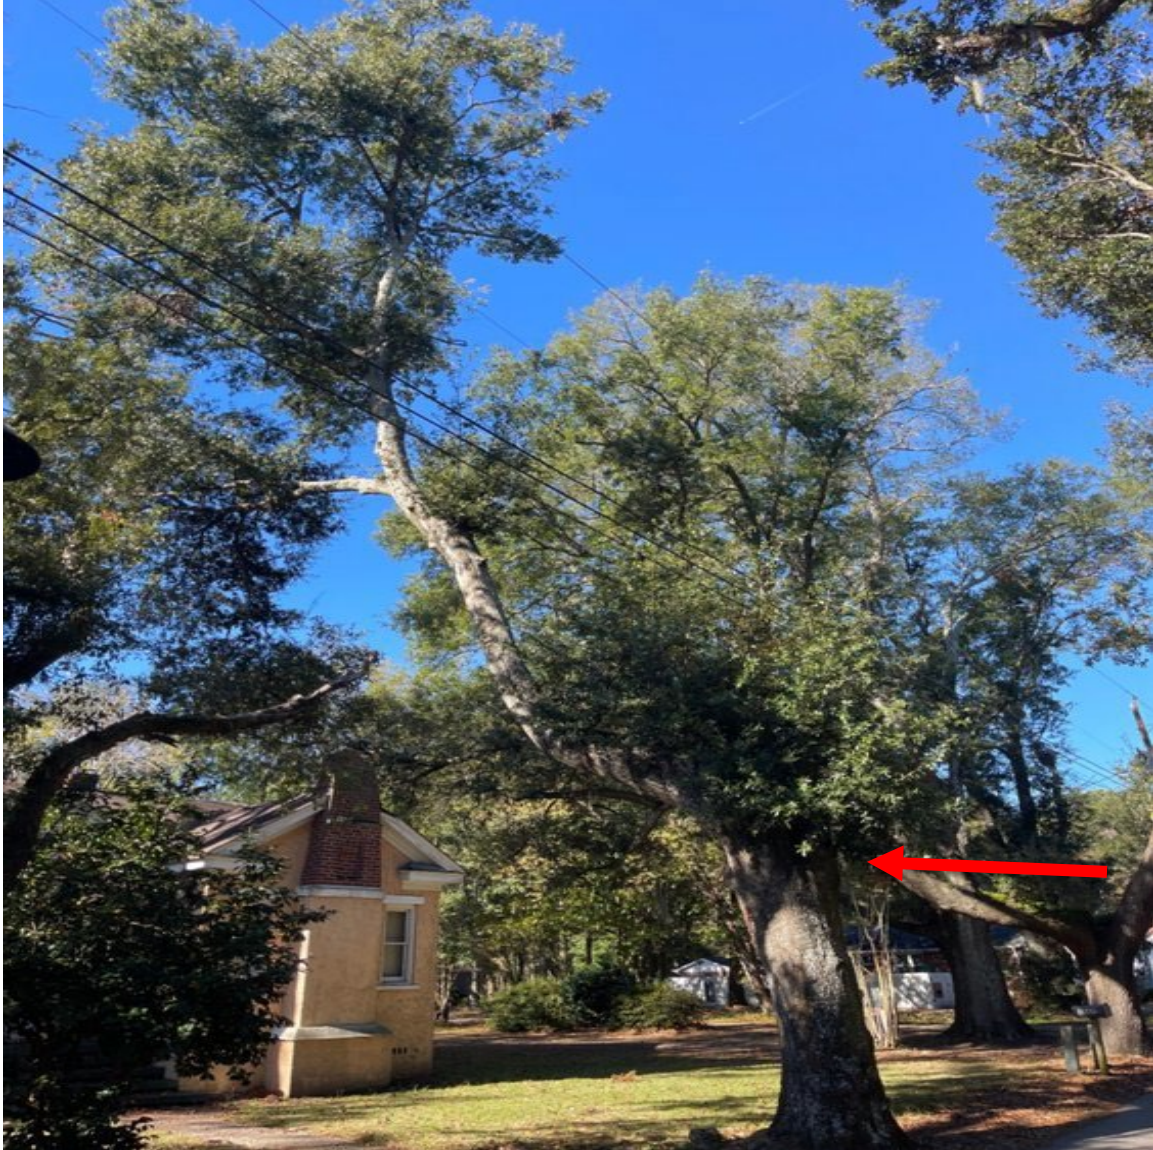
Figure 23: A very damaged and over-pruned tree.

Trees #4, #5 and #6: Do not adjust plans to retain these trees. Complete removal utilizing ANSI A300 Standards for Tree Care Operations.

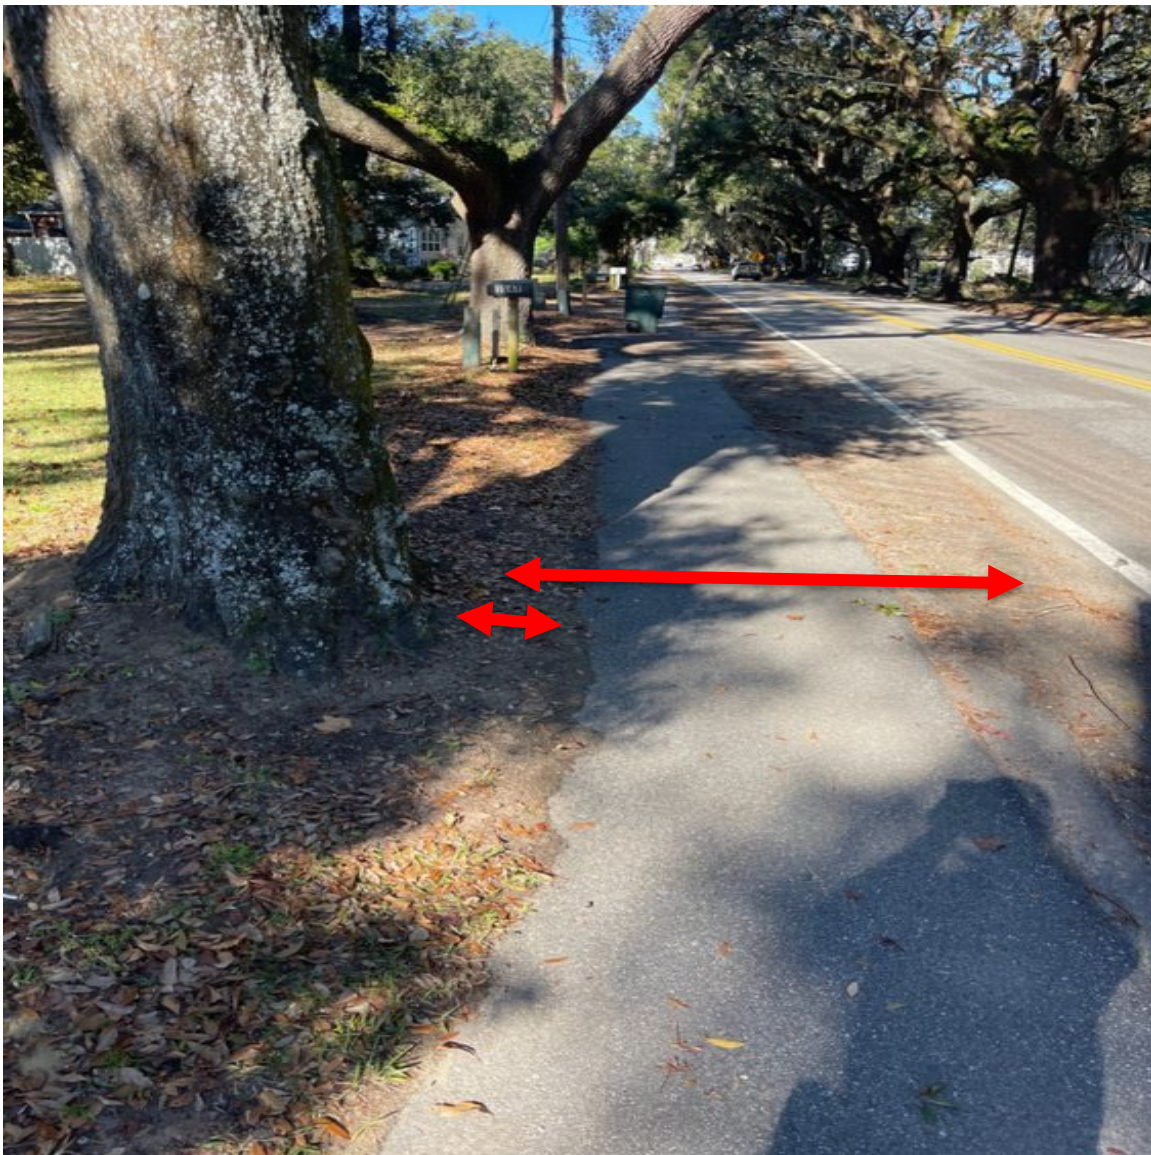
Figure 24: The base of this tree is approx. 1 ft from the walking path and 5-6 ft from the roadway.

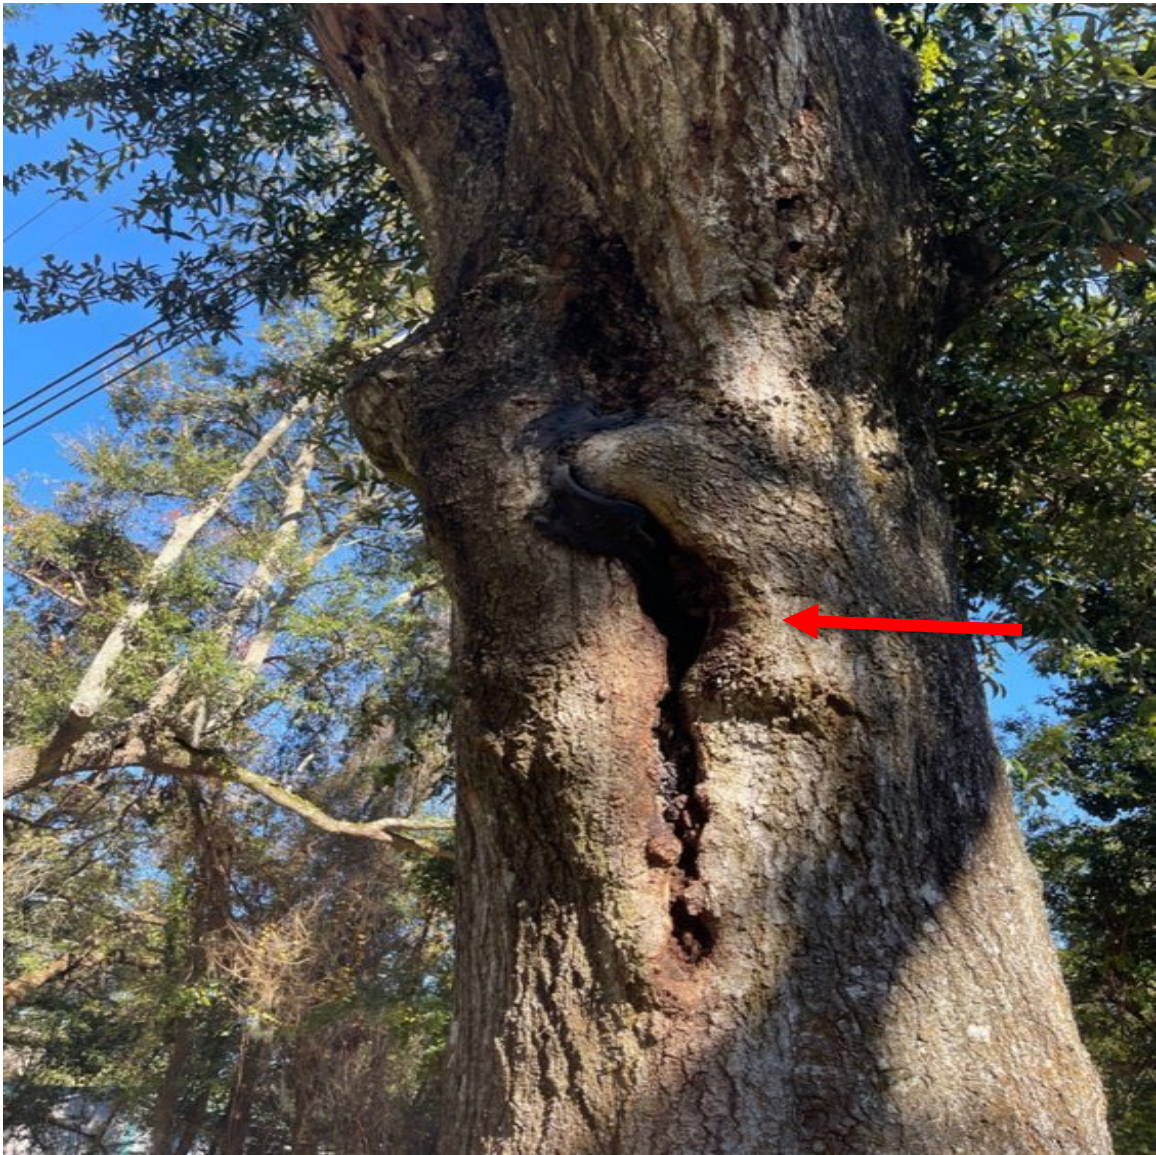
Figure 25: Severe decay and rot discovered in this cavity on the trunk column.

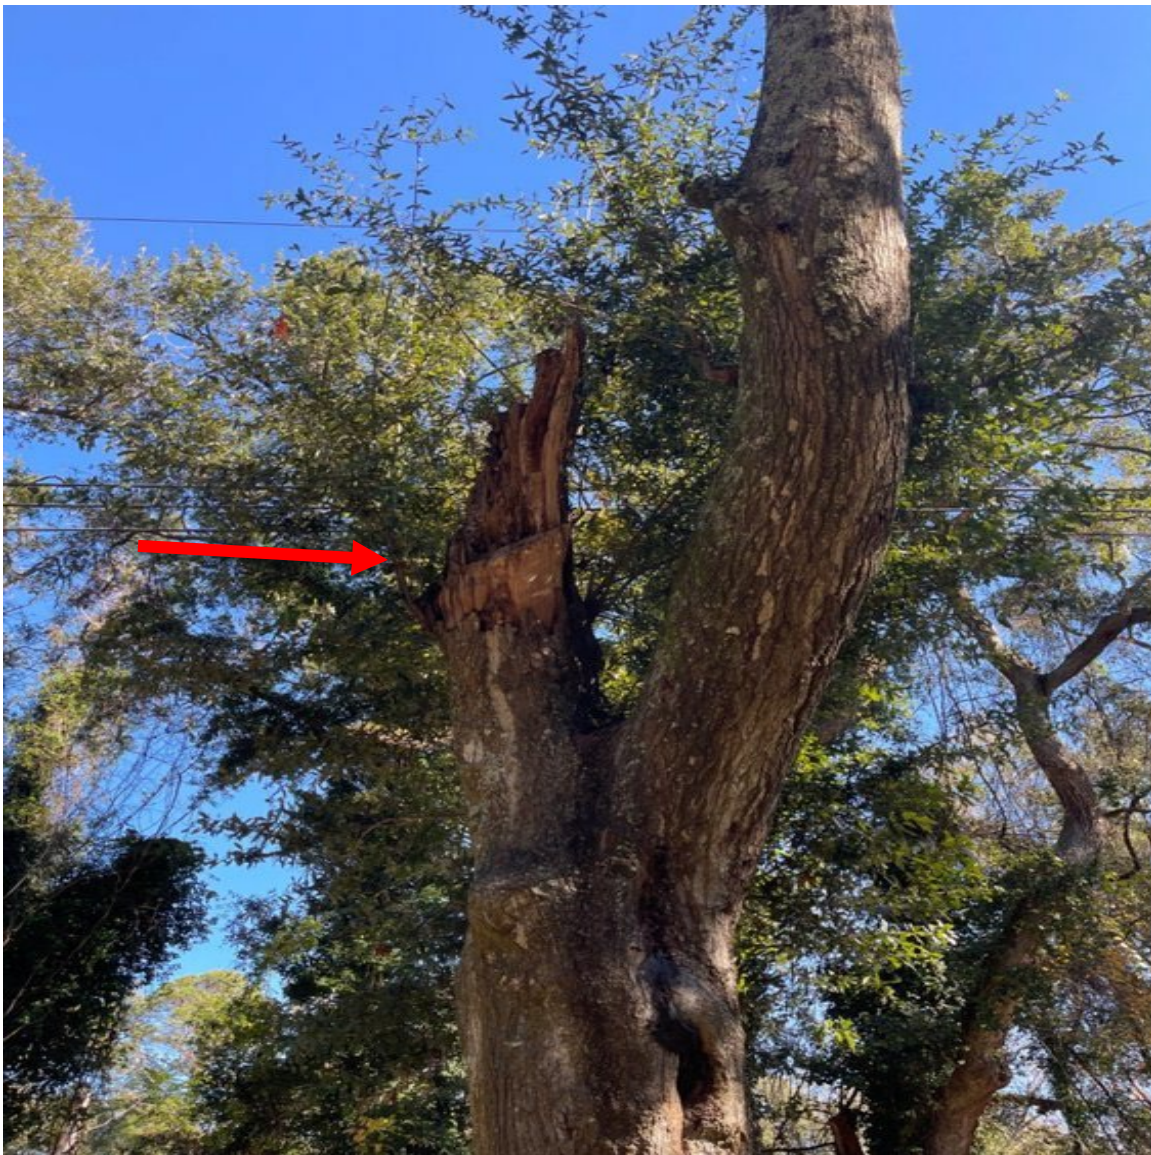
Figure 26: This primary stem failed in a recent storm event.

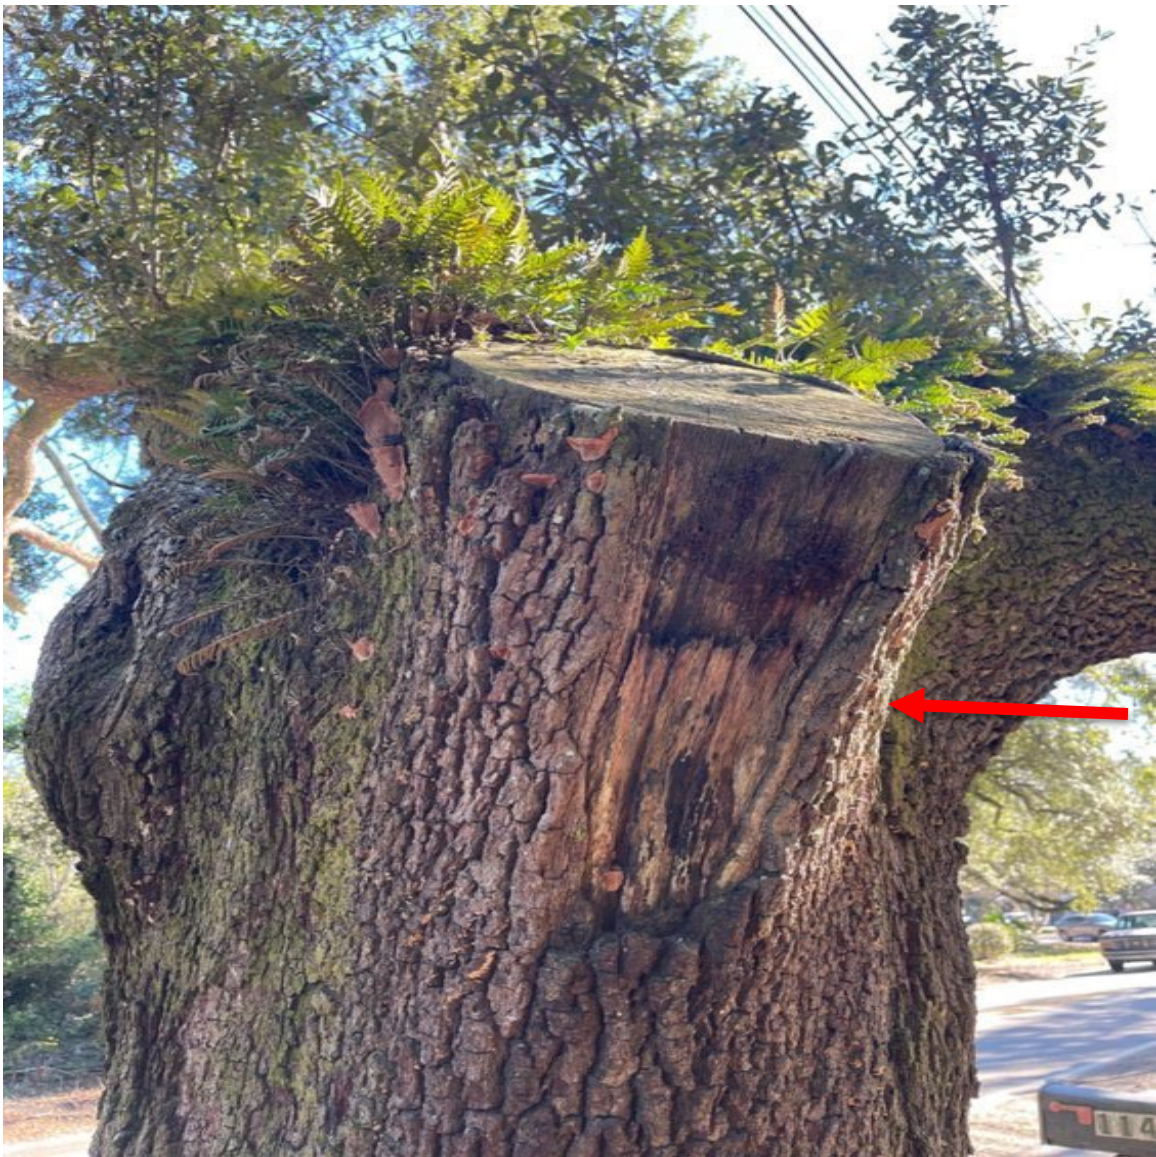
Figure 27: A large stem removed and damaged cambium where the cut was peeled. This area will continue to decay.

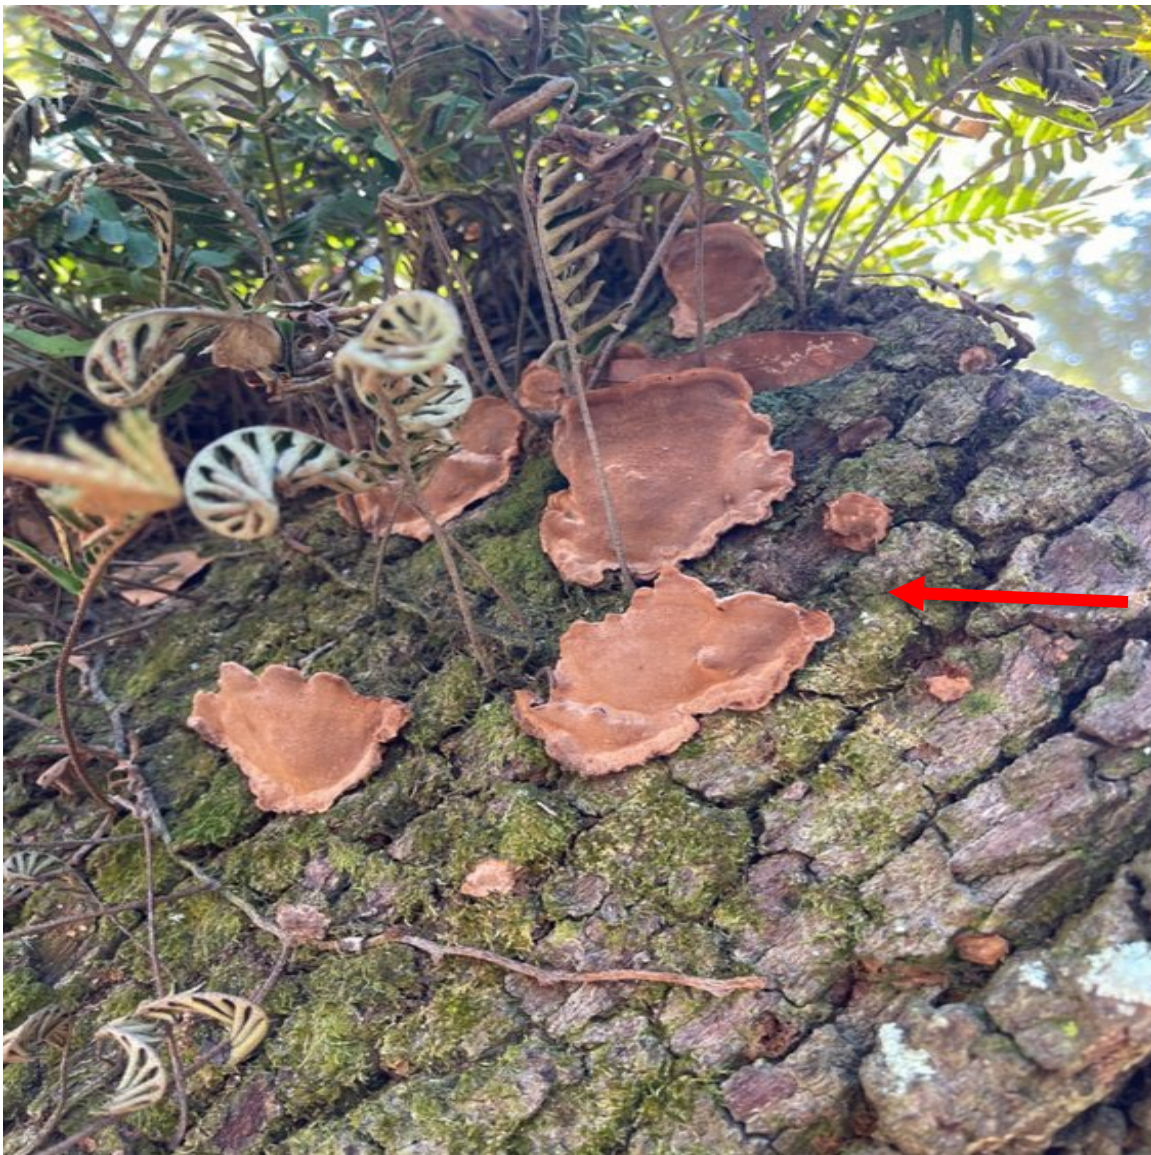
Figure 28: Unknown wood decay fruiting fungal conks.

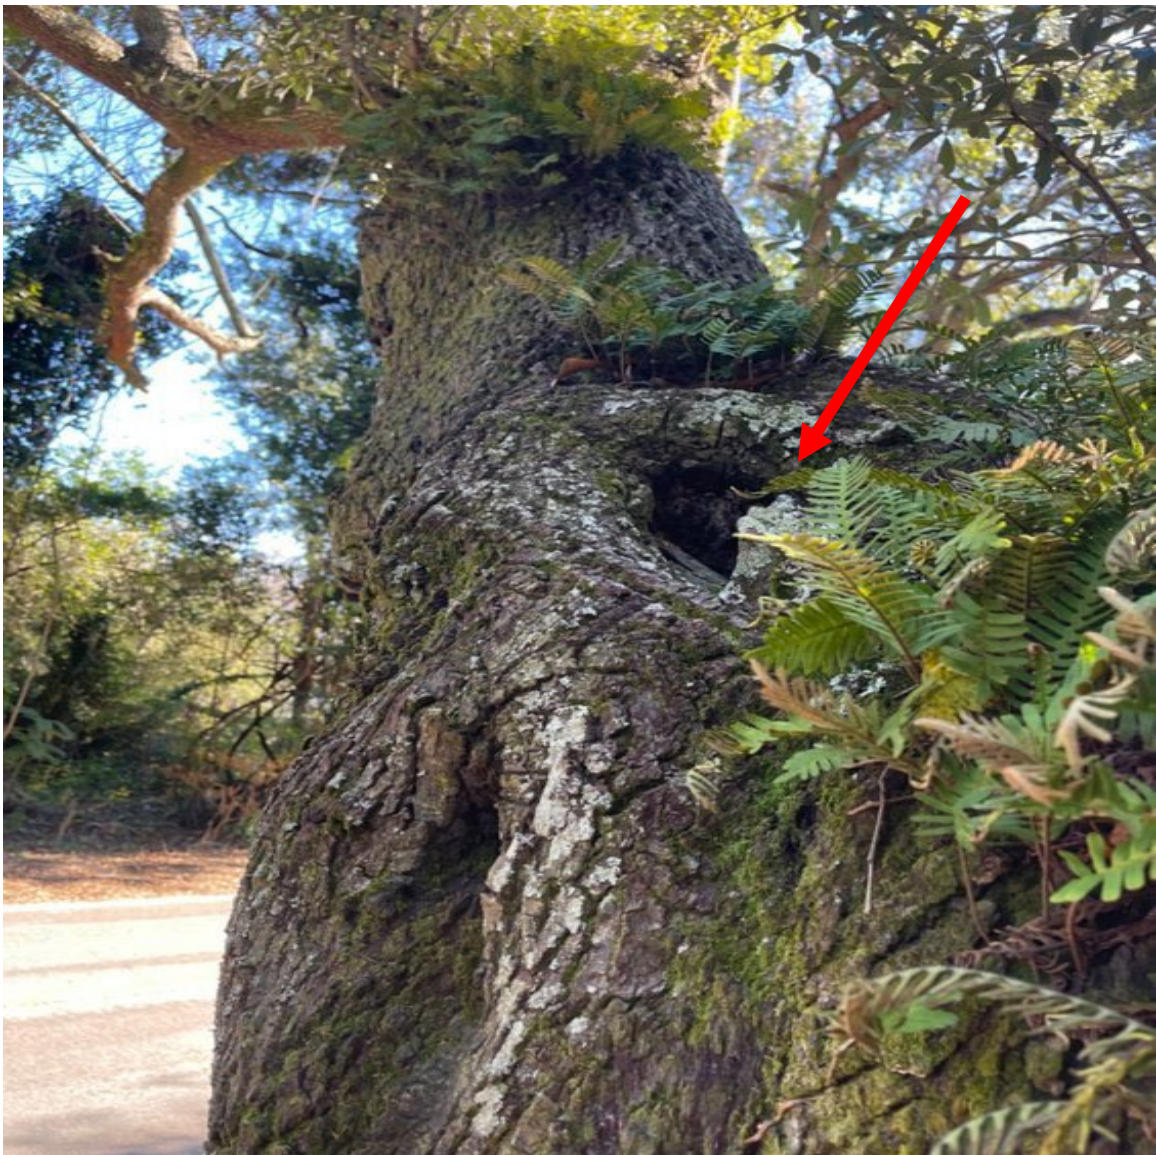
Figure 29: A large cavity at the intersection of what was co-dominant stems primary to the remove of one of the two stems.

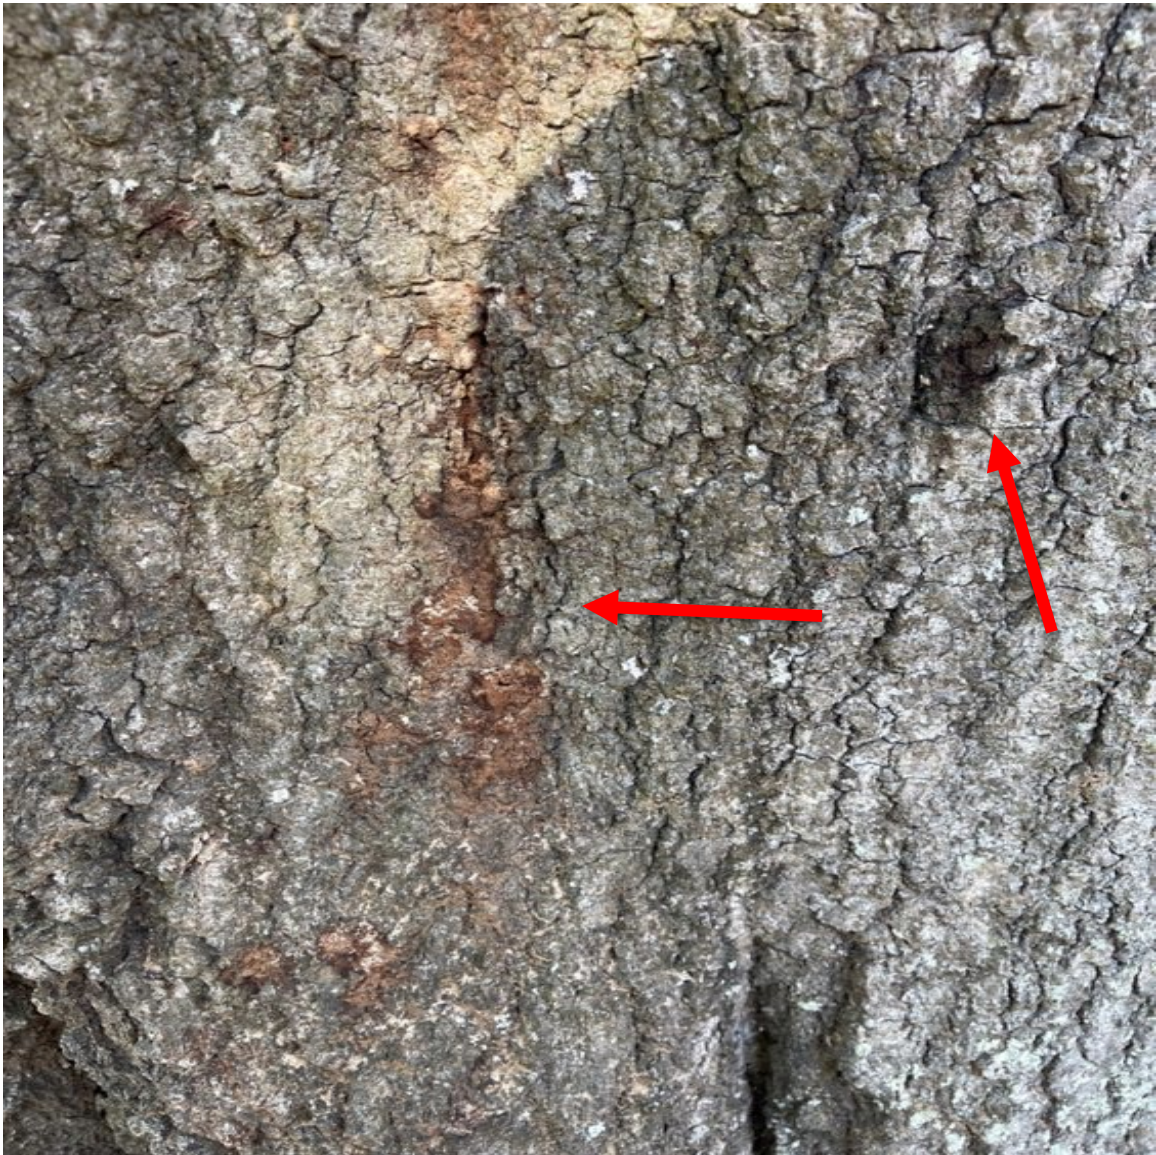
Figure 30: Decay and tannic acid present along the trunk; an indicator of the presence of a wood decay pathogen living in the wood.

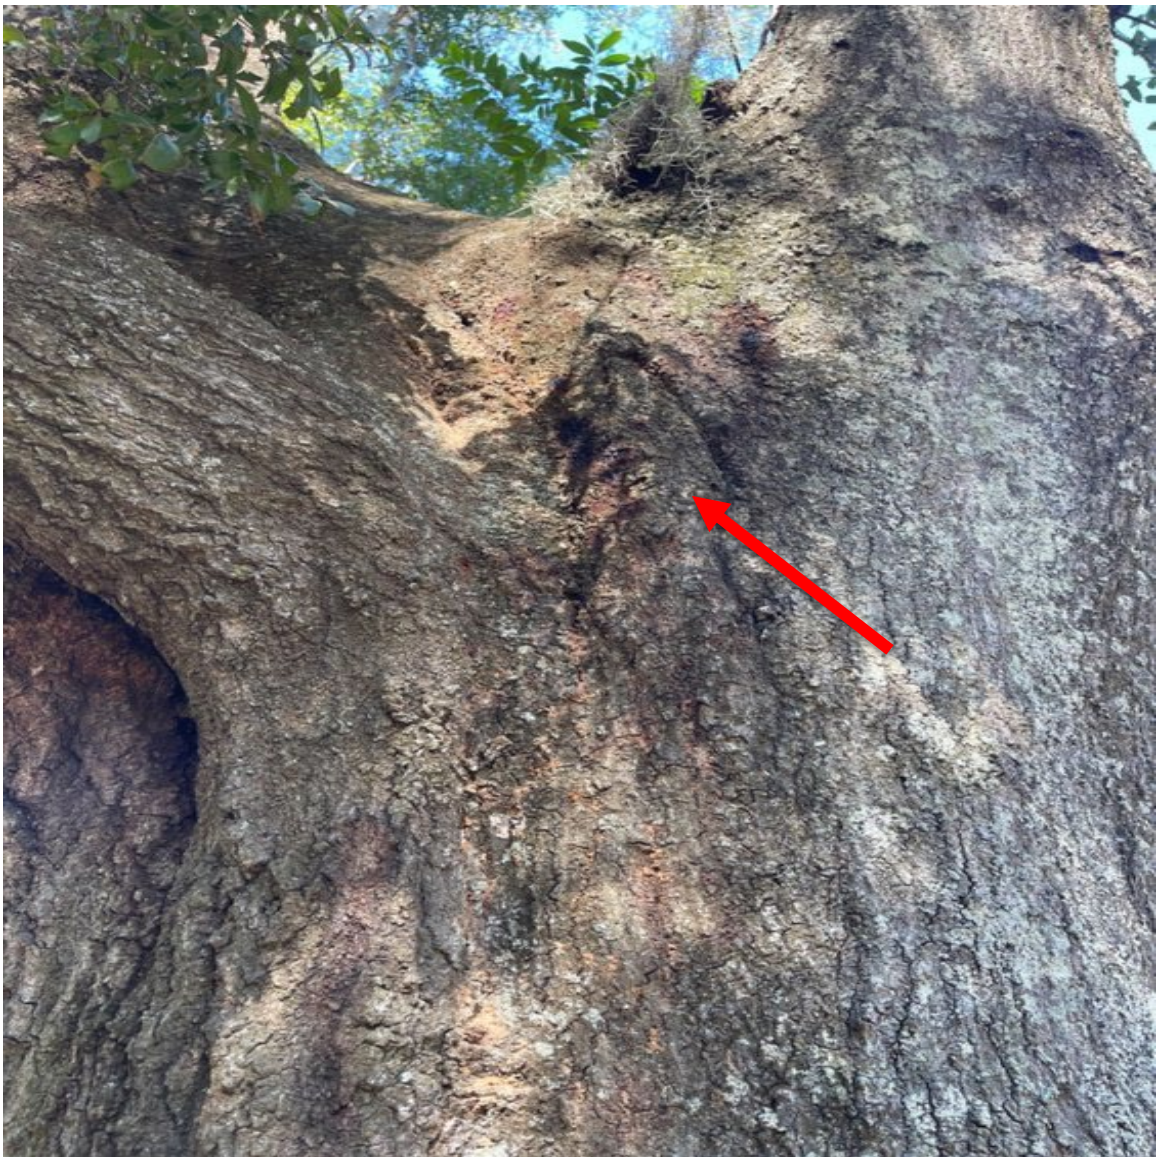
Figure 31: More tannic acid seeping out of the trunk column.
