TREE RISK ASSESSMENT

Camp Road (S-28) at Intersection of Fort Johnson Road (S-94)
Charleston, SC 29412

Don Alexander
Parrish and Partners

January 08, 2023

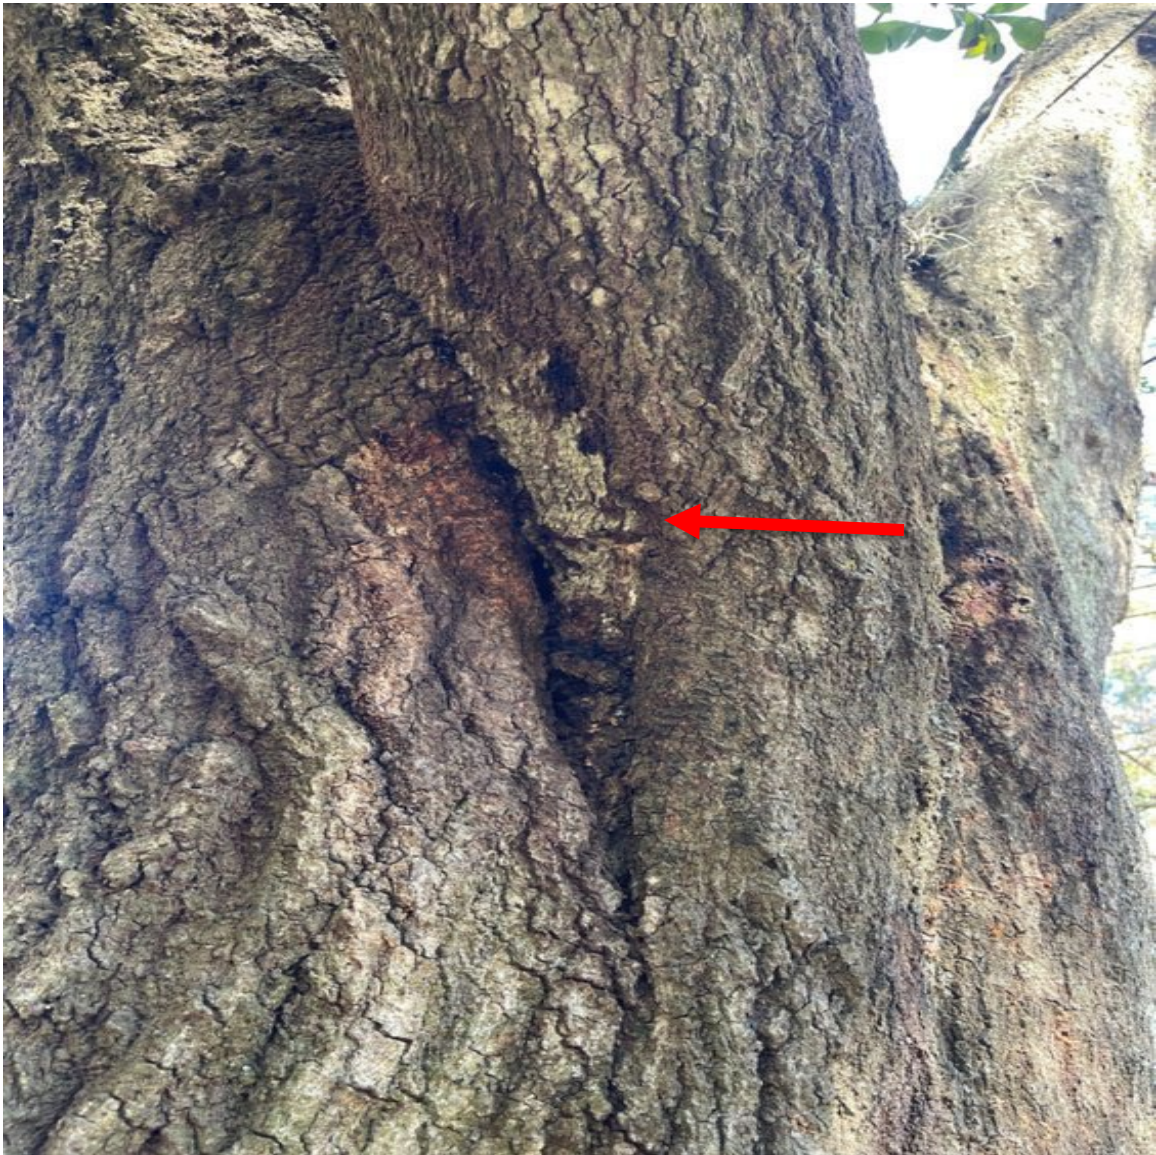
Figure 32: Decay present beneath this stem.

Trees #4, #5 and #6: Do not adjust plans to retain these trees. Complete removal utilizing ANSI A300 Standards for Tree Care Operations.

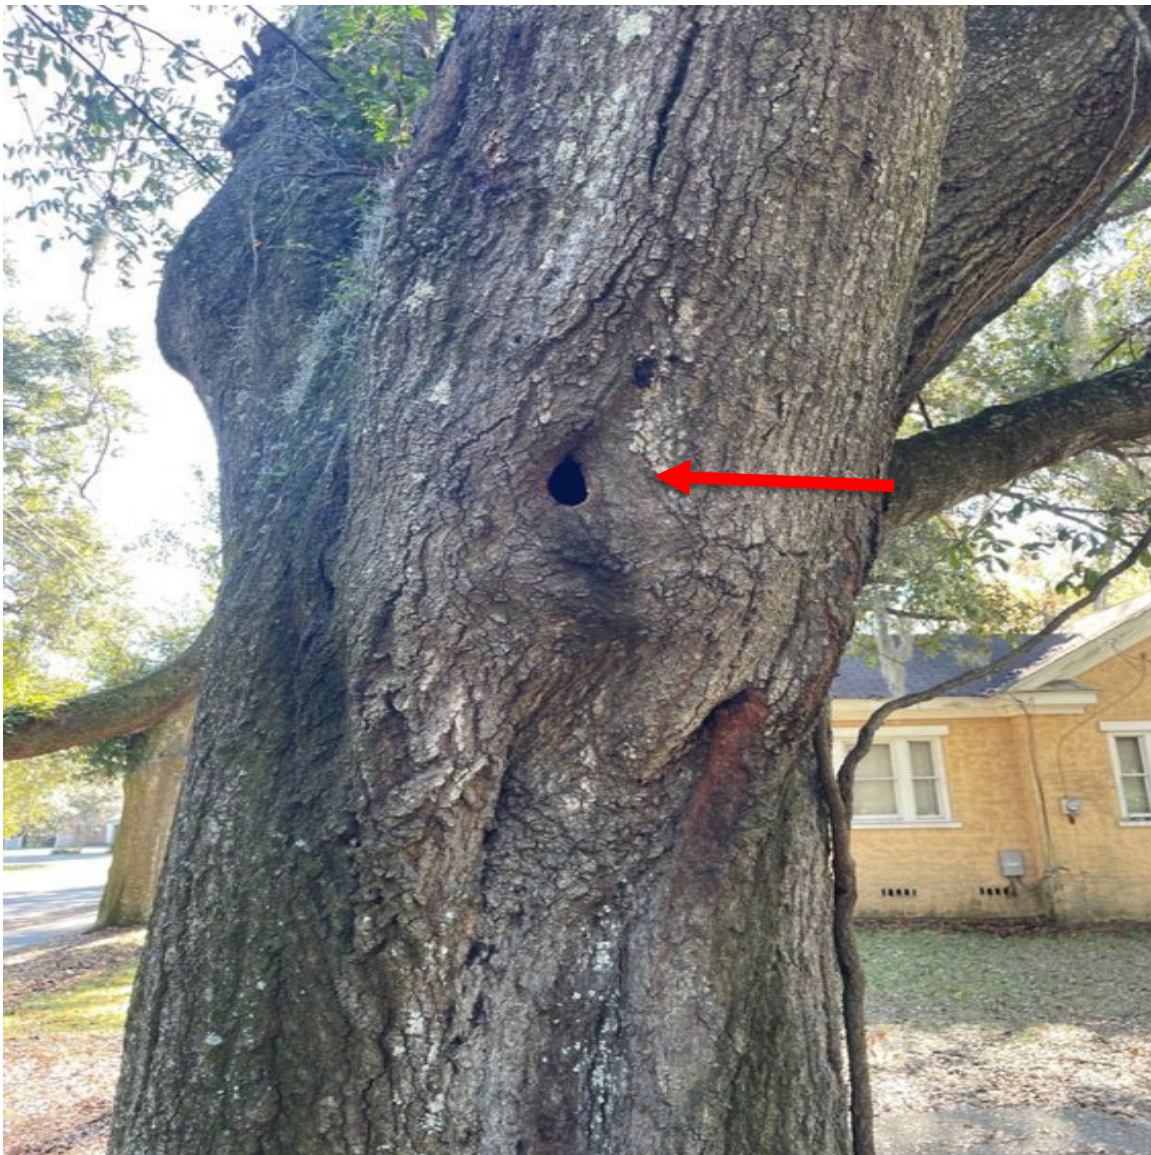
Figure 33: A large cavity in the base of this primary stem.

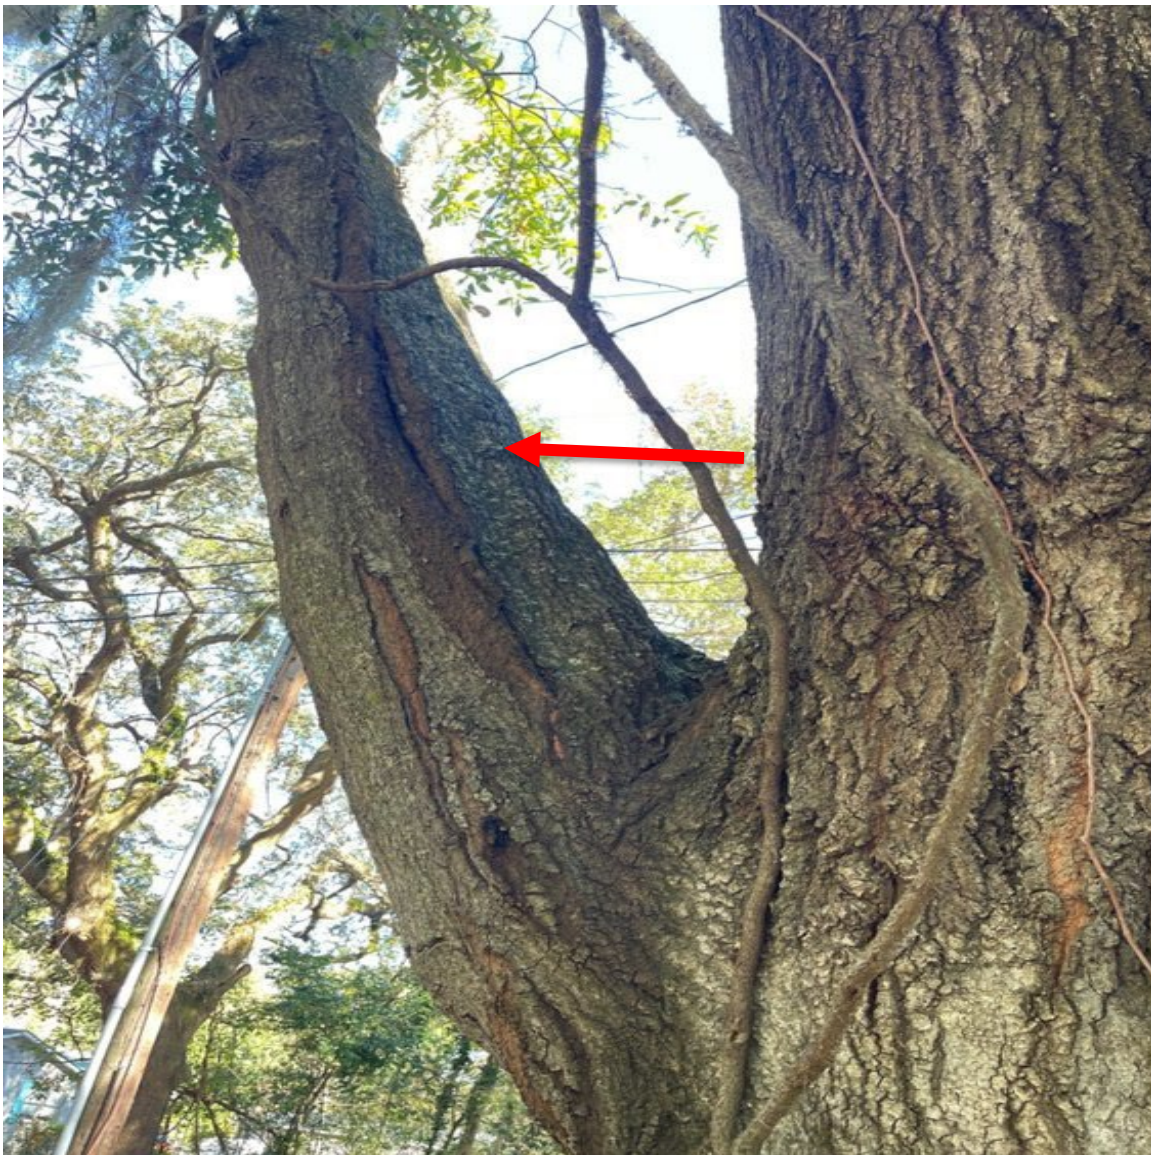
Figure 34: A large shear plane crack in the base of this primary stem.
