TREE RISK ASSESSMENT

Camp Road (S-28) at Intersection of Fort Johnson Road (S-94)
Charleston, SC 29412

Don Alexander
Parrish and Partners

January 08, 2023

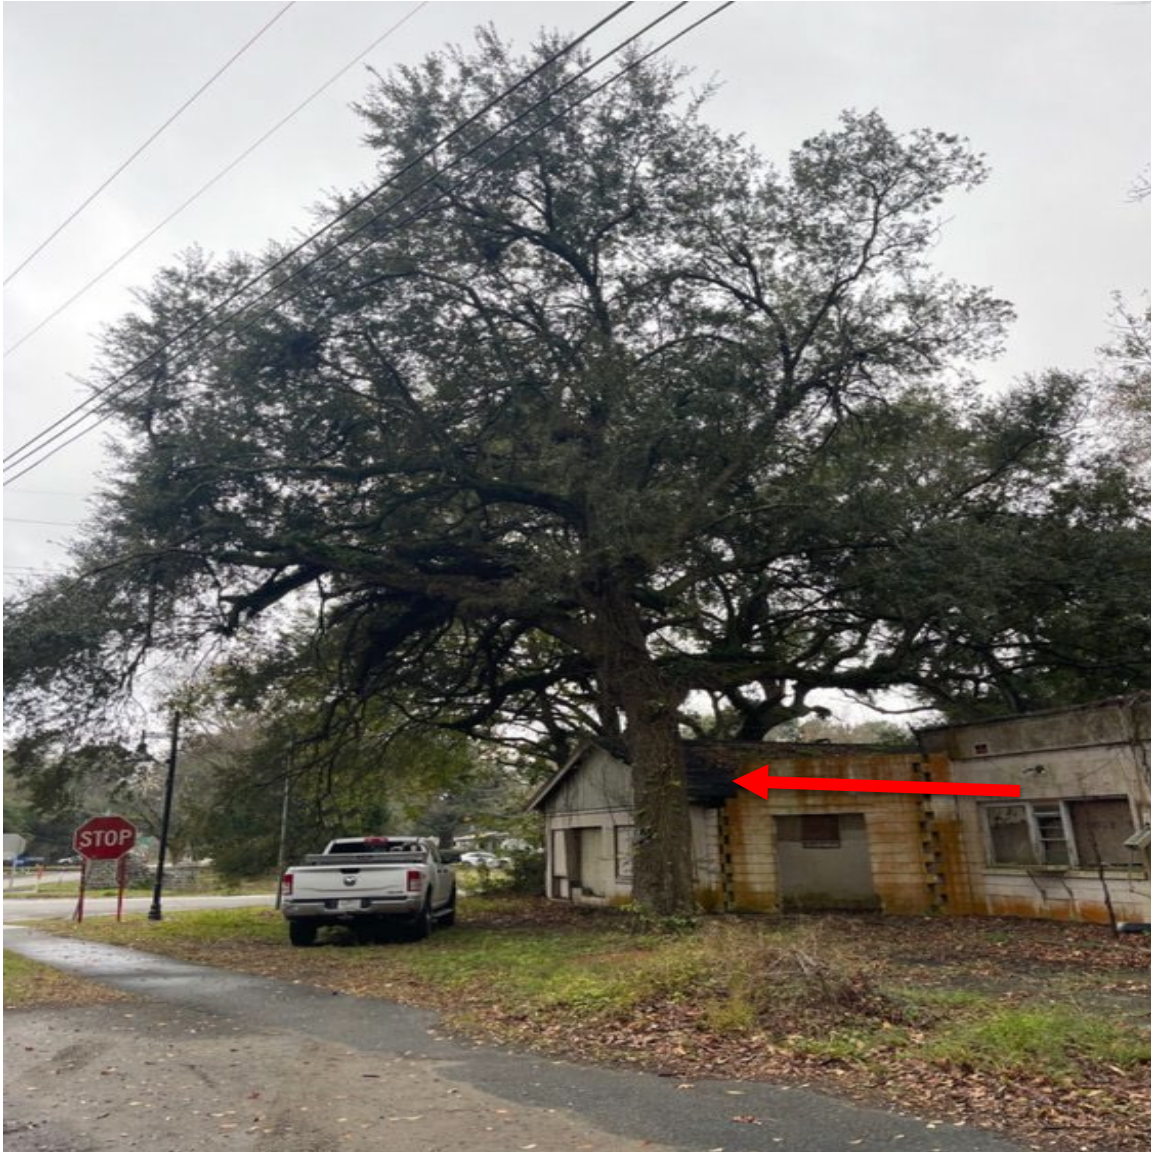
#3 LIVE OAK, *QUERCUS VIRGINIANA*

Figure 20: Minor mechanical injury to the base of the trunk column.

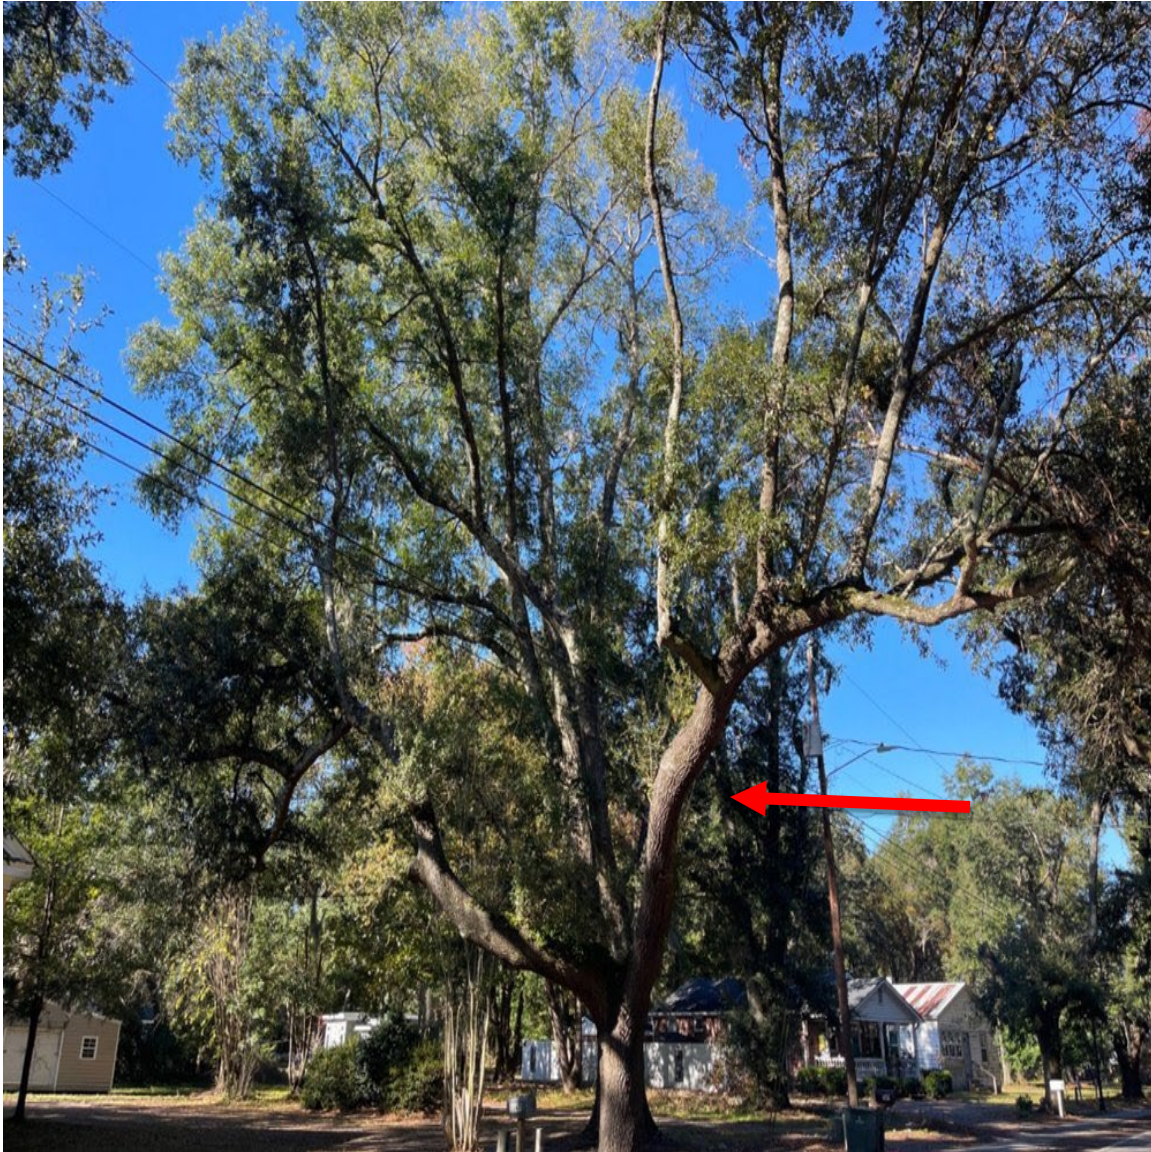
#5 LIVE OAK, *QUERCUS VIRGINIANA*

Figure 27: A large stem removed and damaged cambium where the cut was peeled. This area will continue to decay.

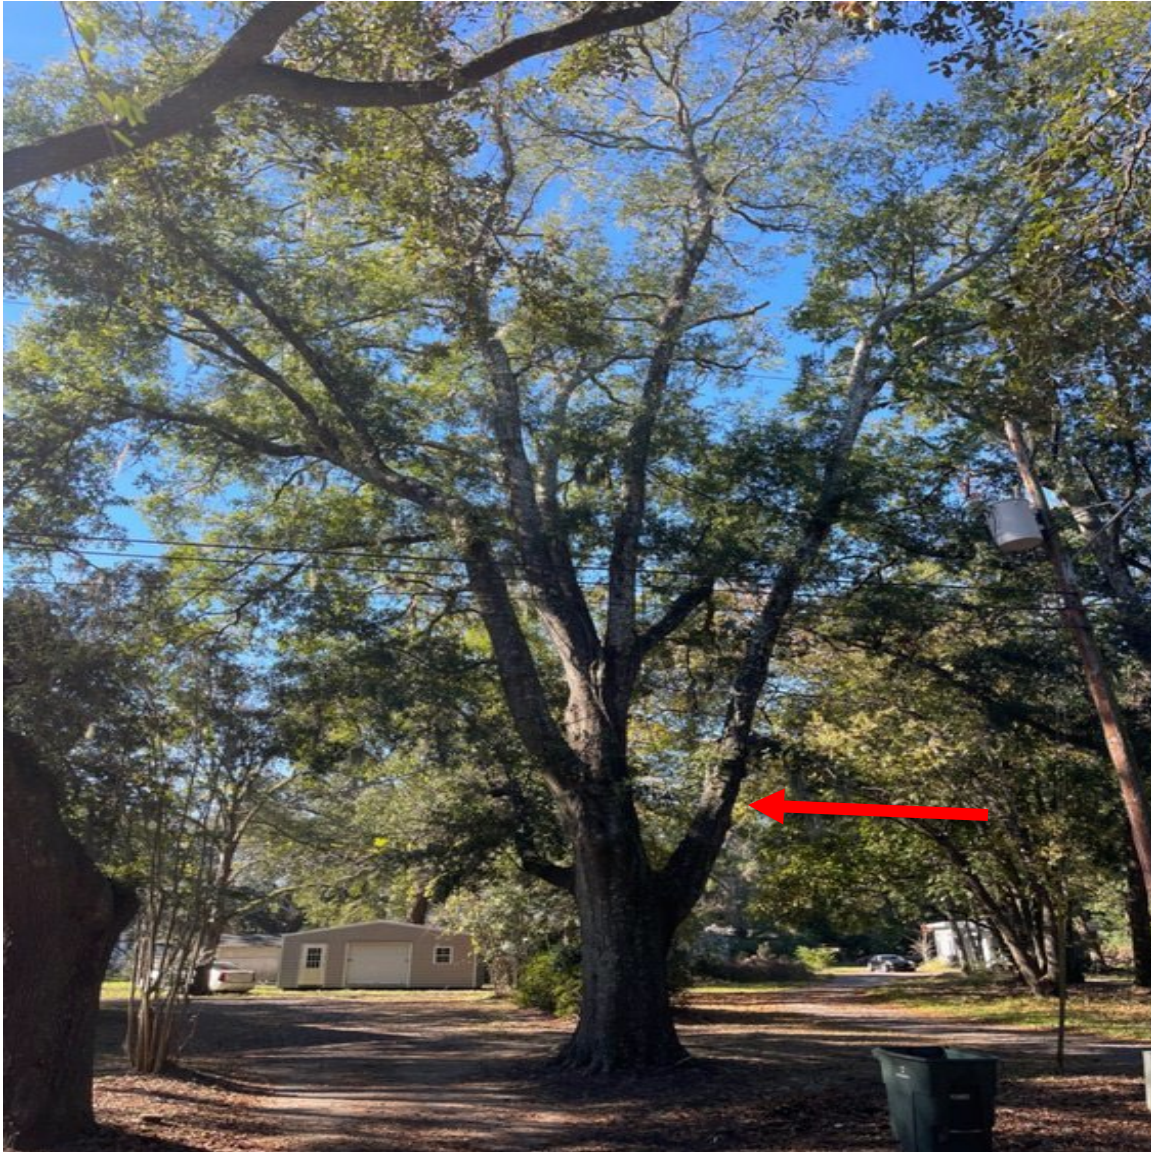
#6 LAUREL OAK, *QUERCUS LAURIFOLIA*

Figure 30: Decay and tannic acid present along the trunk; an indicator of the presence of a wood decay pathogen living in the wood.
